Access Compliance Report

Public Rights-of-Way

(Curb Ramps)

Intersection ID: 10035175	Main Street: QUAIL_HILL_RD	Cross Street: N/A	Location: W
ADA ID: 6B6BF15D9B24	Ramp Type: Perp	Initial Pass/Fail: Fail	Overall Compliance: No
		Severity Score: 8.75

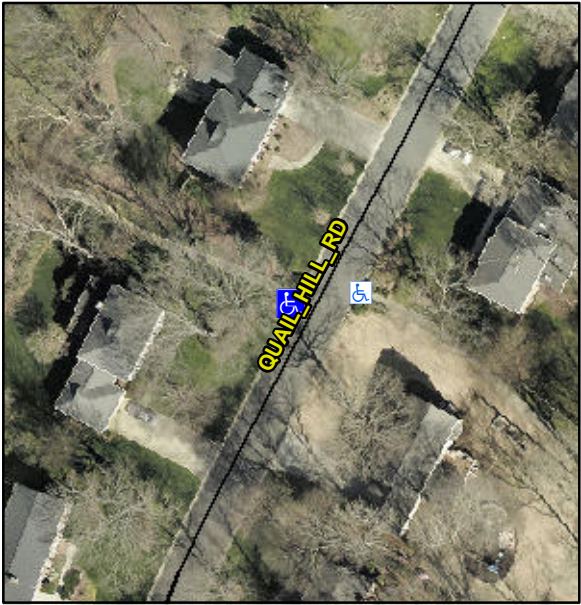
Possible Solutions:		Compliance	Description	Data
	Remove & Replace Entire Ramp.		N/A	Ramp Length (in)	48.0
			No	Ramp Width (in)	47.0
			N/A	Flare Type LT	N/A
			N/A	Flare Slope LT (%)	N/A
			N/A	Flare Traversable LT?	N/A
			N/A	Landing Length (in)	N/A
			N/A	Landing Width (in)	N/A
			N/A	Landing Slope (%)	N/A
			N/A	Landing X Slope (%)	N/A
<p>Surveyor Notes:</p> <p>N/A</p> <p>PROW/ADA:</p> <p>R304.5.1</p>			N/A	Flare Type RT	N/A
			N/A	Flare Slope RT (%)	N/A
			N/A	Flare Traversable RT?	N/A
			N/A	DWS Provided?	N/A
			N/A	DWS Contrast?	N/A
			N/A	DWS Length (in)	N/A
			N/A	DWS Full Width?	N/A
			N/A	DWS Offset (in)	N/A
			N/A	Shared Landing?	N/A
			N/A	Gutter Ponding?	N/A
			N/A	Gutter Lip Ht (in)	N/A
			N/A	Painted X Walk1?	No
				X Walk 1 Direction	To E
			N/A	X Walk 1 Width (in)	N/A
				X Walk 1 Slope (%)	10.0
				X Walk 1 X Slope (%)	0.8

N/A	Ramp inside XWalk1?	N/A
			N/A	Road Slope (%)	N/A
			N/A	Road X Slope (%)	N/A
			N/A	Any Obstructions?	N/A
				Obstruction Type	
			N/A		N/A
			Yes	Surface Condition? (G/P)	Good
