Access Compliance Report

Public Rights-of-Way

(Curb Ramps)

Intersection ID: N/A	Main Street: CORLISS_AV	Cross Street: ROGALLA_DR	Location: SE
ADA ID: 6B783DD5E7C0	Ramp Type: PerpDiag	Initial Pass/Fail: Fail	Overall Compliance: No
Severity Score: 22.5			
Codes/Mitigation Info/Possible Solution		Field Measurements/Component Compliance

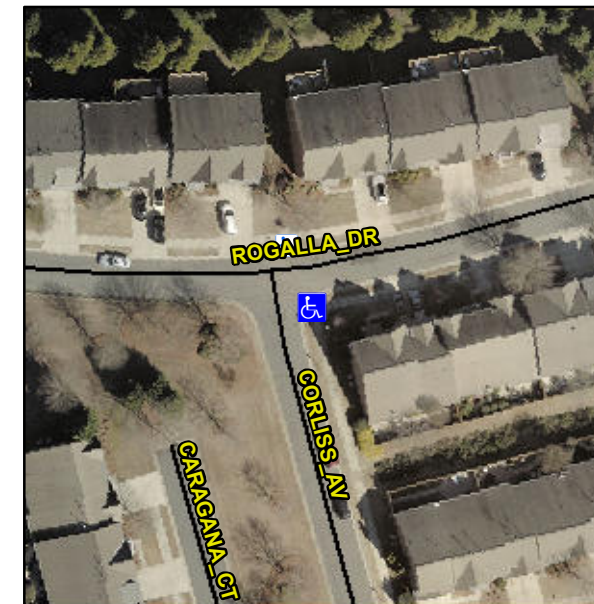
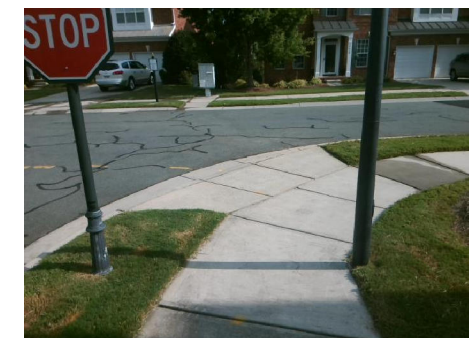
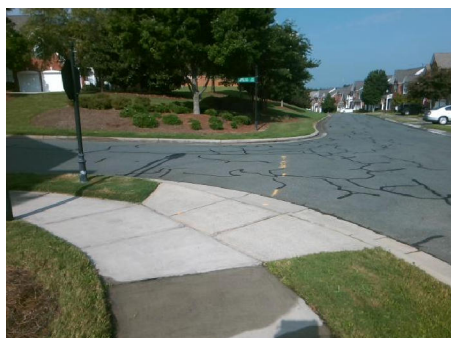
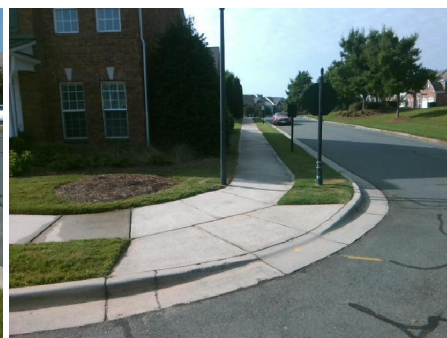
Not Found, R304.5.1, R304.2.2, R304.5.3

Compliance	Description	Data	Compliance	Description	Data
N/A	Ramp Length (in)	107.0	No	Ramp Slope (%)	8.7
No	Ramp Width (in)	37.0	No	Ramp XSlope (%)	4.2
N/A	Flare Type LT	N/A	N/A	Flare Type RT	N/A
N/A	Flare Slope LT (%)	N/A	N/A	Flare Slope RT (%)	N/A
N/A	Flare Traversable LT?	N/A	N/A	Flare Traversable RT?	N/A
N/A	Landing Length (in)	N/A	N/A	DWS Provided?	N/A
N/A	Landing Width (in)	N/A	N/A	DWS Contrast?	N/A
N/A	Landing Slope (%)	N/A	N/A	DWS Length (in)	N/A
N/A	Landing X Slope (%)	N/A	N/A	DWS Full Width?	N/A
N/A	Landing Curb? (Y/N)	N/A	N/A	DWS Offset (in)	N/A
N/A	Shared Landing?	N/A			
N/A	Gutter Ponding?	N/A	N/A	Gutter Slope (%)	N/A
N/A	Gutter Lip Ht (in)	N/A	N/A	Gutter X Slope (%)	N/A
N/A	Painted X Walk1?	No	N/A	Painted X Walk2?	No
	X Walk 1 Direction	To N		X Walk 2 Direction	To W
N/A	X Walk 1 Width (in)	N/A	N/A	X Walk 2 Width (in)	N/A
	X Walk 1 Slope (%)	0.7		X Walk 2 Slope (%)	2.8
	X Walk 1 X Slope (%)	1.1		X Walk 2 X Slope (%)	0.9

N/A	Ramp inside XWalk1?	N/A	N/A	Ramp inside XWalk2?	N/A
	Road Slope (%)	1.1	N/A	Clear Space?	N/A
	Road X Slope (%)	0.7	N/A	Clear Space to XWalk (in)	N/A
N/A	Any Obstructions?	N/A	N/A	Storm Grate/Utility Hazard?	N/A
	Obstruction Type			Storm Grate/Utility Type	
		N/A			N/A
			Yes	Surface Condition? (G/P)	Good

Possible Solutions:

Remove & Replace Curb Ramp With Two New Directional Ramps or Equivalent.
