Access Compliance Report Public Rights-of-Way (Curb Ramps)

Main Street: COMMONWEALTH_AV Intersection ID: 13337 **Cross Street: GORDON_ST** Location: SE ADA ID: 6B86D0336046 Ramp Type: Directional1 Initial Pass/Fail: Fail **Overall Compliance: No** Severity Score: 13.75

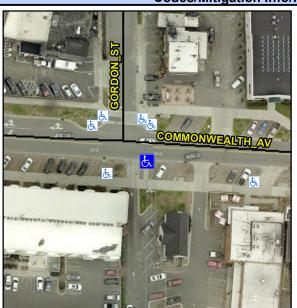
Possible Solution		Field Measurements/Component Compliance				
Possible Solutions:	Comp	Compliance Description		Comp	ance Description	
Remove & Replace Entire Ramp.	N/A	Ramp Length (in)	107.0	N/A	Grade Break?	
·	Yes	Ramp Width (in)	56.0	N/A	Grade Break Slope (%)	
	No	Ramp Slope (%)	8.4	N/A	Grade Break XSlope (%)	
	No	Ramp XSlope (%)	3.5			
	N/A	Flare Type LT	N/A	N/A	Flare Type RT	
	N/A	Flare Slope LT (%)	N/A	N/A	Flare Slope RT (%)	
Surveyor Notes:	N/A	Flare Traversable LT?	N/A	N/A	Flare Traversable RT?	
N/A	N/A	Landing Length (in)	0.0	N/A	DWS Provided?	
	N/A	Landing Width (in)	0.0	N/A	DWS Contrast?	
	N/A	Landing Slope (%)	0.0	N/A	DWS Length (in)	
	N/A	Landing X Slope (%)	0.0	N/A	DWS Full Width?	
PROW/ADA:	N/A	Landing Curb? (Y/N)	N/A	N/A	DWS Offset LT (in)	
R304.2.2, R304.5.3	N/A	Shared Landing?	N/A	N/A	DWS Offset RT (in)	
	N/A	Gutter Ponding?	0.0	N/A	Gutter Slope (%)	
	N/A	Gutter Lip Ht (in)	0.0	N/A	Gutter X Slope (%)
