# Access Compliance Report

## Public Rights-of-Way

### (Curb Ramps)

| Intersection ID: 46918 | Main Street: BLUE_ASH_LN | Cross Street: PONDEROSA_PINE_LN | Location: NE |

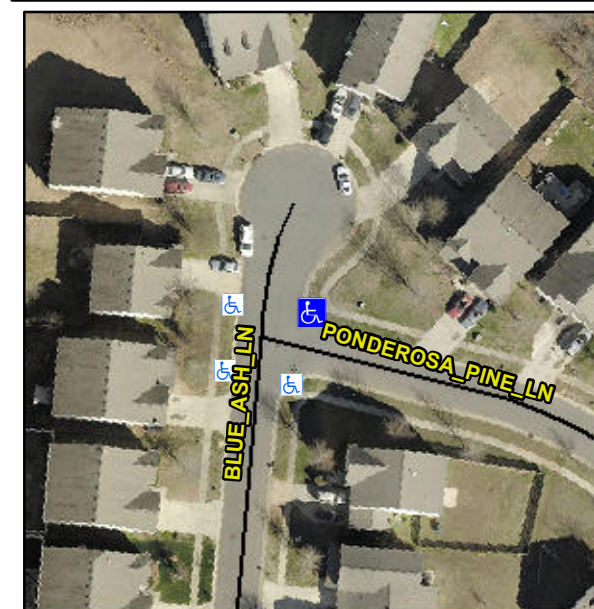
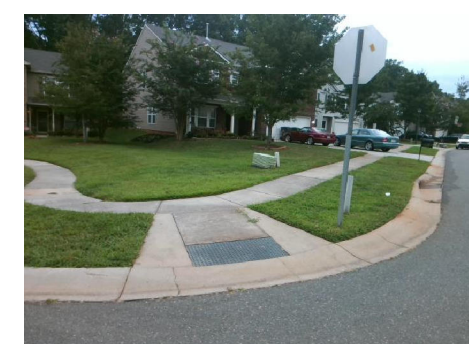
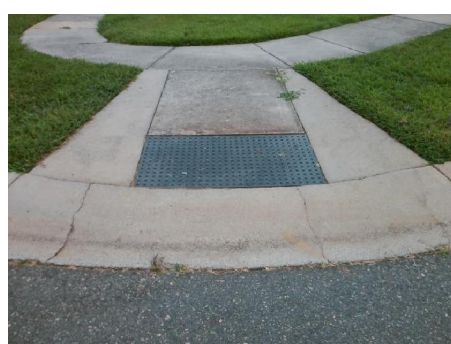
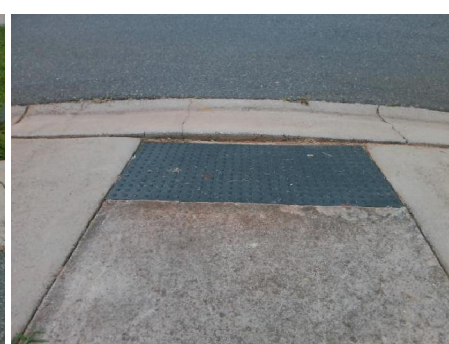
| ADA ID: 6BB36C15895F | Ramp Type: PerpDiag | Initial Pass/Fail: Fail | Overall Compliance: No |
| Severity Score: 33.75 | | | |

**Not Found, R304.5.1, R304.2.2, R304.5.3**

| Compliance | Description | Data | Compliance | Description | Data |
|---|---|---|---|---|---|
| N/A | Ramp Length (in) | 86.5 | No | Ramp Slope (%) | 8.9 |
| No | Ramp Width (in) | 46.5 | No | Ramp XSlope (%) | 5.9 |

**Remove & Replace Curb Ramp With Two New Directional Ramps or Equivalent.**

Total Cost: \$ 3200.00
