Access Compliance Report

Public Rights-of-Way

(Curb Ramps)

Intersection ID: 54373	Main Street: BENSEVAL_LN	Cross Street: ARNOTT_LN	Location: E
ADA ID: 6BBA70CF047A	Ramp Type: PerpDiag	Initial Pass/Fail: Fail	Overall Compliance: No
Codes/Mitigation Info/Possible Solution		Field Measurements/Component Compliance

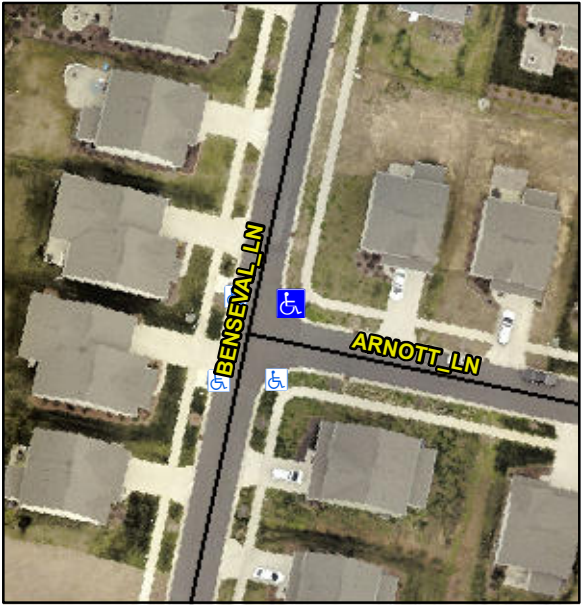
Possible Solutions:	Compliance	Description	Data	Compliance	Description	Data
	Remove & Replace Curb Ramp With Two New Directional Ramps or Equivalent.	N/A	Ramp Length (in)	110.0	No	Ramp Slope (%)	8.6
<p>Surveyor Notes:</p> <p>N/A</p> <p>PROW/ADA:</p> <p>Not Found, R304.2.2, R304.5.3</p>		Yes	Ramp Width (in)	48.0	No	Ramp XSlope (%)	4.7
		N/A	Flare Type LT	N/A	N/A	Flare Type RT	N/A
		N/A	Flare Slope LT (%)	N/A	N/A	Flare Slope RT (%)	N/A
		N/A	Flare Traversable LT?	N/A	N/A	Flare Traversable RT?	N/A
		N/A	Landing Length (in)	N/A	N/A	DWS Provided?	N/A
		N/A	Landing Width (in)	N/A	N/A	DWS Contrast?	N/A
		N/A	Landing Slope (%)	N/A	N/A	DWS Length (in)	N/A
		N/A	Landing X Slope (%)	N/A	N/A	DWS Full Width?	N/A
		N/A	Landing Curb? (Y/N)	N/A	N/A	DWS Offset (in)	N/A
		N/A	Shared Landing?	N/A			
		N/A	Gutter Ponding?	N/A	N/A	Gutter Slope (%)	N/A
		N/A	Gutter Lip Ht (in)	N/A	N/A	Gutter X Slope (%)	N/A
		N/A	Painted X Walk1?	No	N/A	Painted X Walk2?	No

X Walk 1 Direction	To NW		X Walk 2 Direction	To SW
		N/A	X Walk 1 Width (in)	N/A	N/A	X Walk 2 Width (in)	N/A
			X Walk 1 Slope (%)	2.9		X Walk 2 Slope (%)	0.6
			X Walk 1 X Slope (%)	3.2		X Walk 2 X Slope (%)	1.4
		N/A	Ramp inside XWalk1?	N/A	N/A	Ramp inside XWalk2?	N/A
			Road Slope (%)	4.0	N/A	Clear Space?	N/A
			Road X Slope (%)	2.0	N/A	Clear Space to XWalk (in)	N/A
		N/A	Any Obstructions?	N/A	N/A	Storm Grate/Utility Hazard?	N/A
			Obstruction Type			Storm Grate/Utility Type	
					N/A		N/A
					Yes	Surface Condition? (G/P)	Good
