Access Compliance Report

Public Rights-of-Way

(Curb Ramps)

Intersection ID: 27494	Main Street: BALLANTYNE COMMONS PY	Cross Street: SUMMIT COMMONS BV	Location: S
ADA ID: 6BC3D25B2665	Ramp Type: Perp	Initial Pass/Fail: Fail	Overall Compliance: No
Severity Score: 22.5			
Codes/Mitigation Info/Possible Solution		Field Measurements/Component Compliance

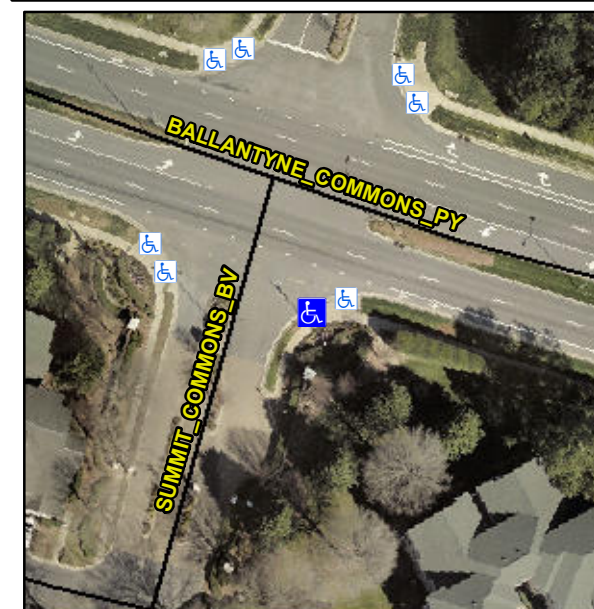
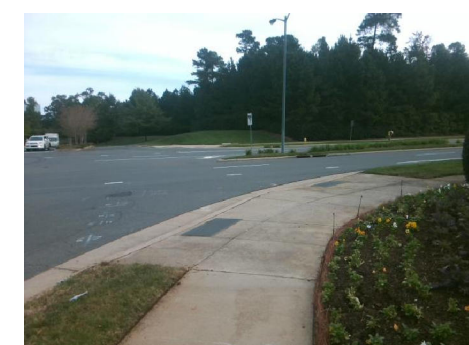
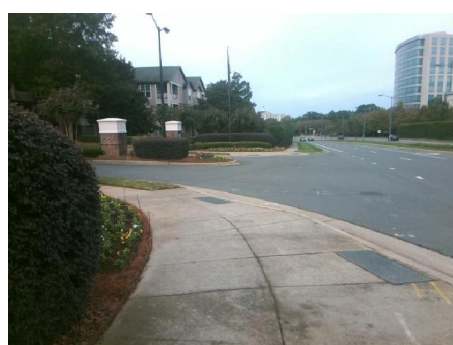
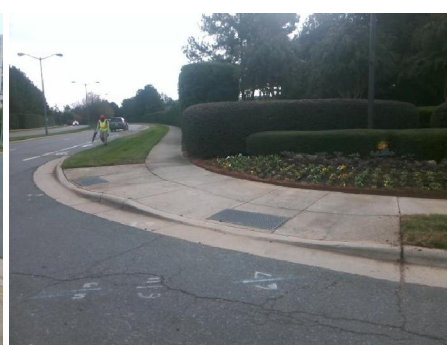
Not Found, R304.5.1, R304.2.2, R304.5.3

Compliance	Description	Data	Compliance	Description	Data
N/A	Ramp Length (in)	106.0	No	Ramp Slope (%)	8.4
No	Ramp Width (in)	42.0	No	Ramp XSlope (%)	2.2
N/A	Flare Type LT	N/A	N/A	Flare Type RT	N/A
N/A	Flare Slope LT (%)	N/A	N/A	Flare Slope RT (%)	N/A
N/A	Flare Traversable LT?	N/A	N/A	Flare Traversable RT?	N/A
N/A	Landing Length (in)	N/A	N/A	DWS Provided?	N/A
N/A	Landing Width (in)	N/A	N/A	DWS Contrast?	N/A
N/A	Landing Slope (%)	N/A	N/A	DWS Length (in)	N/A
N/A	Landing X Slope (%)	N/A	N/A	DWS Full Width?	N/A
N/A	Landing Curb? (Y/N)	N/A	N/A	DWS Offset (in)	N/A
N/A	Shared Landing?	N/A			
N/A	Gutter Ponding?	N/A	N/A	Gutter Slope (%)	N/A
N/A	Gutter Lip Ht (in)	N/A	N/A	Gutter X Slope (%)	N/A
N/A	Painted X Walk1?	No	N/A	Painted X Walk2?	N/A
	X Walk 1 Direction	To NW		X Walk 2 Direction	N/A
N/A	X Walk 1 Width (in)	N/A	N/A	X Walk 2 Width (in)	N/A
	X Walk 1 Slope (%)	5.4		X Walk 2 Slope (%)	N/A
	X Walk 1 X Slope (%)	1.0		X Walk 2 X Slope (%)	N/A

N/A	Ramp inside XWalk1?	N/A	N/A	Ramp inside XWalk2?	N/A
	Road Slope (%)	N/A	N/A	Clear Space?	N/A
	Road X Slope (%)	N/A	N/A	Clear Space to XWalk (in)	N/A
N/A	Any Obstructions?	N/A	N/A	Storm Grate/Utility Hazard?	N/A
	Obstruction Type			Storm Grate/Utility Type	
		N/A			N/A
			Yes	Surface Condition? (G/P)	Good

Possible Solutions:

Remove & Replace Entire Ramp.

Total Cost: \$ 1850.00
