# Access Compliance Report

## Public Rights-of-Way

### (Curb Ramps)

Intersection ID: 16396	Main Street: BEAL_ST	Cross Street: N_WENDOVER_RD	Location: SW
ADA ID: 6BD0B5C55589	Ramp Type: Perp	Initial Pass/Fail: Fail	Overall Compliance: No
Severity Score: 12.5			
Codes/Mitigation Info/Possible Solution		Field Measurements/Component Compliance

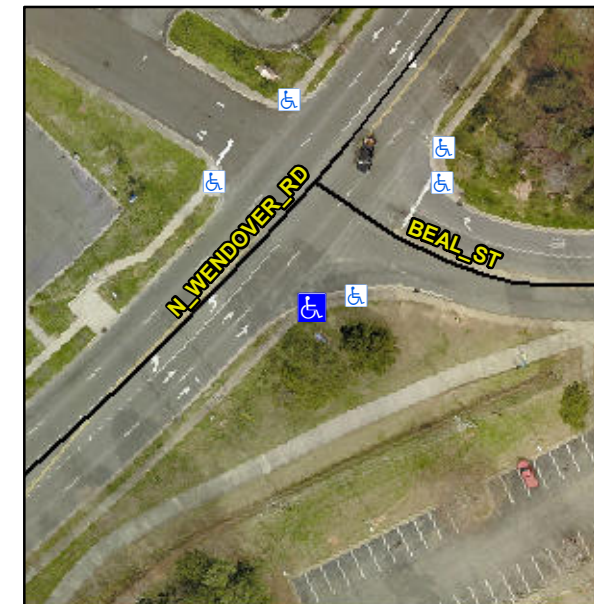
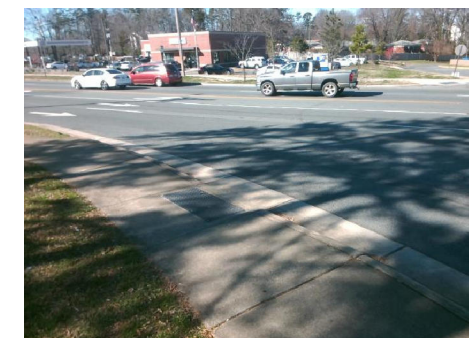
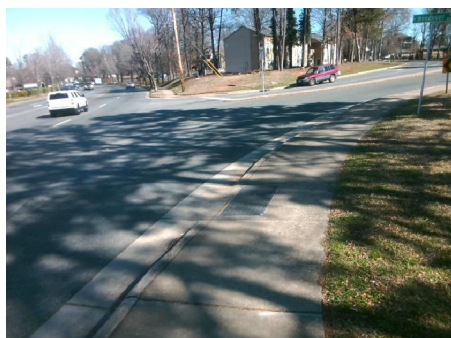
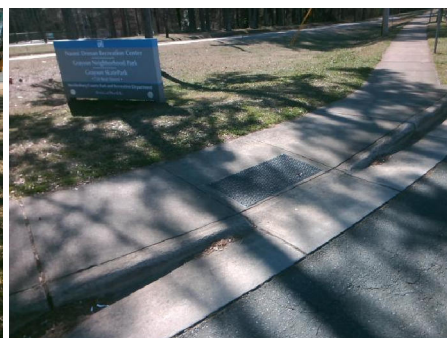
**Not Found, R304.2.2**

Compliance	Description	Data	Compliance	Description	Data
N/A	Ramp Length (in)	60.0	No	Ramp Slope (%)	8.9
Yes	Ramp Width (in)	56.0	Yes	Ramp XSlope (%)	1.5
N/A	Flare Type LT	N/A	N/A	Flare Type RT	N/A
N/A	Flare Slope LT (%)	N/A	N/A	Flare Slope RT (%)	N/A
N/A	Flare Traversable LT?	N/A	N/A	Flare Traversable RT?	N/A
N/A	Landing Length (in)	N/A	N/A	DWS Provided?	N/A
N/A	Landing Width (in)	N/A	N/A	DWS Contrast?	N/A
N/A	Landing Slope (%)	N/A	N/A	DWS Length (in)	N/A
N/A	Landing X Slope (%)	N/A	N/A	DWS Full Width?	N/A
N/A	Landing Curb? (Y/N)	N/A	N/A	DWS Offset (in)	N/A
N/A	Shared Landing?	N/A			
N/A	Gutter Ponding?	N/A	N/A	Gutter Slope (%)	N/A
N/A	Gutter Lip Ht (in)	N/A	N/A	Gutter X Slope (%)	N/A
N/A	Painted X Walk1?	No	N/A	Painted X Walk2?	N/A
	X Walk 1 Direction	To NW		X Walk 2 Direction	N/A
N/A	X Walk 1 Width (in)	N/A	N/A	X Walk 2 Width (in)	N/A
	X Walk 1 Slope (%)	4.3		X Walk 2 Slope (%)	N/A
	X Walk 1 X Slope (%)	0.9		X Walk 2 X Slope (%)	N/A

N/A	Ramp inside XWalk1?	N/A	N/A	Ramp inside XWalk2?	N/A
	Road Slope (%)	N/A	N/A	Clear Space?	N/A
	Road X Slope (%)	N/A	N/A	Clear Space to XWalk (in)	N/A
N/A	Any Obstructions?	N/A	N/A	Storm Grate/Utility Hazard?	N/A
	Obstruction Type			Storm Grate/Utility Type	
		N/A			N/A
			Yes	Surface Condition? (G/P)	Good

**Remove & Replace Entire Ramp.**

Total Cost: \$ 1850.00
