# Access Compliance Report

## Public Rights-of-Way

### (Curb Ramps)

Intersection ID: 15205		Main Street: CHEROKEE_RD		Cross Street: FENTON_PL		Location: NE											
ADA ID: 6BD9CACDCE96		Ramp Type: Directional1		Initial Pass/Fail: Fail		Overall Compliance: No		Severity Score: 1.25									
Codes/Mitigation Info/Possible Solution				Field Measurements/Component Compliance													
<div>

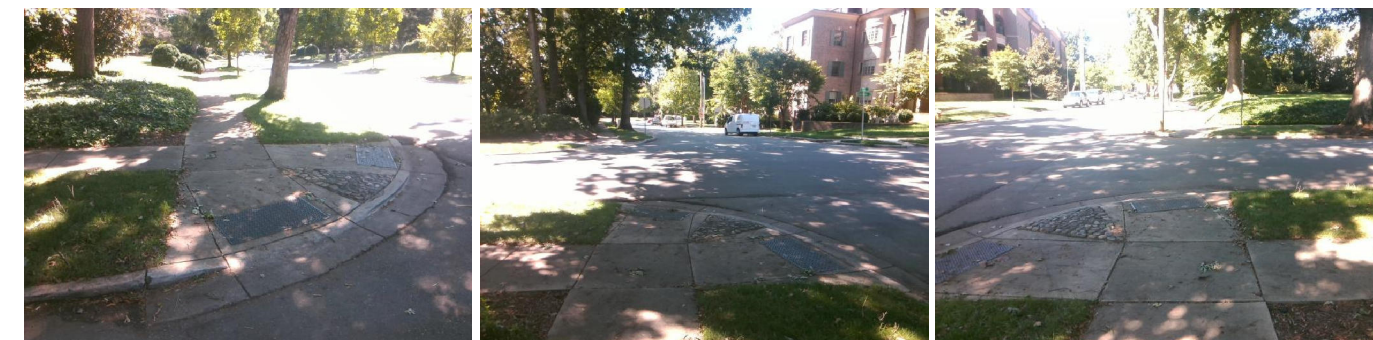
Yes		Ramp Slope (%)		1.8		N/A		Grade Break XSlope (%)		0.0		0.0	
				No		Ramp XSlope (%)		3.9									
				N/A		Flare Type LT		N/A		N/A		Flare Type RT		N/A		N/A	
				N/A		Flare Slope LT (%)		N/A		N/A		Flare Slope RT (%)		0.0		0.0	
				N/A		Flare Traversable LT?		N/A		N/A		Flare Traversable RT?		N/A		N/A	
				N/A		Landing Length (in)		0.0		N/A		DWS Provided?		N/A		N/A	
				N/A		Landing Width (in)		0.0		N/A		DWS Contrast?		N/A		N/A	
				N/A		Landing Slope (%)		0.0		N/A		DWS Length (in)		N/A		N/A	
				N/A		Landing X Slope (%)		0.0		N/A		DWS Full Width?		N/A		N/A	
				N/A		Landing Curb? (Y/N)		N/A		N/A		DWS Offset LT (in)		N/A		N/A	
				N/A		Shared Landing?		N/A		N/A		DWS Offset RT (in)		N/A		N/A	
				N/A		Gutter Ponding?		0.0		N/A		Gutter Slope (%)		N/A		N/A	
				N/A		Gutter Lip Ht (in)		0.0		N/A		Gutter X Slope (%)		N/A		N/A	
				N/A		Painted X Walk1?		No				Road Slope (%)		5.6		5.6	
						X Walk 1 Direction		To NW				Road X Slope (%)		0.5		0.5

X Walk 1 Width (in)		N/A				Clear Space?		N/A		N/A	
						X Walk 1 Slope (%)		5.6		N/A		Clear Space to XWalk (in)		N/A		N/A	
						X Walk 1 X Slope (%)		0.5		N/A		Storm Grate/Utility Hazard?		N/A		N/A	
				N/A		Ramp inside XWalk1?		N/A				Storm Grate/Utility Type					
				N/A		Any Obstructions?		N/A						N/A		N/A	
						Obstruction Type				Yes		Surface Condition? (G/P)		Good		Good	
										N/A		N/A		Curb Slope (%)		9.3

</div> <div>Possible Solutions:</div> <div>Remove &amp; Replace Entire Ramp.</div> <div>Surveyor Notes:</div> <div>N/A</div> <div>PROW/ADA:</div> <div>R304.5.3</div> <div>Street 1 Name</div> <div>FENTON PL</div> <div>Stop Condition-Street 1</div> <div>StopSign</div> <div>Street 2 Name</div> <div>N/A</div> <div>Stop Condition-Street 2</div> <div>N/A</div> <div>Total Cost:</div> <div>\$</div> <div>1600.00</div>				Compliance		Description		Data		Compliance		Description		Data			
				N/A		Ramp Length (in)		71.0		N/A		Grade Break?		N/A		N/A	
				Yes		Ramp Width (in)		58.0		N/A		Grade Break Slope (%)		0.0		0.0
