Access Compliance Report

Public Rights-of-Way

(Curb Ramps)

| Intersection ID: N/A | Main Street: OUTLETS_BV | Cross Street: DESIGNER_DR | Location: NW |

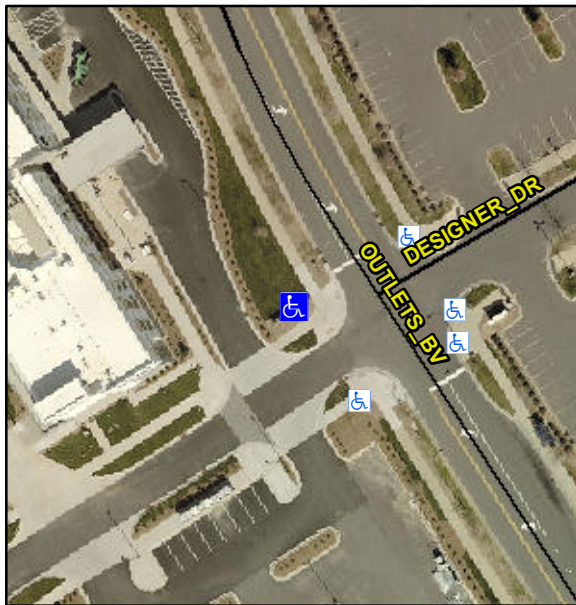
| ADA ID: 6BDD1D1C89CF | Ramp Type: PerpDiag | Initial Pass/Fail: Fail | Overall Compliance: No |

| Compliance | Description | Data | Compliance | Description | Data |
|---|---|---|---|---|---|
| N/A | Ramp Length (in) | 95.0 | Yes | Ramp Slope (%) | 7.4 |
| No | Ramp Width (in) | 47.5 | No | Ramp XSlope (%) | 2.6 |

Remove & Replace Curb Ramp With Two New Directional Ramps or Equivalent.
