Access Compliance Report

Public Rights-of-Way

(Curb Ramps)

Intersection ID: 43739	Main Street: BRIDGEMOUNT_AV	Cross Street: BRIDGEVIEW_LN	Location: NE
ADA ID: 6BE60D1BB01A	Ramp Type: PerpDiag	Initial Pass/Fail: Fail	Overall Compliance: No
Severity Score: 33.75			
Codes/Mitigation Info/Possible Solution		Field Measurements/Component Compliance

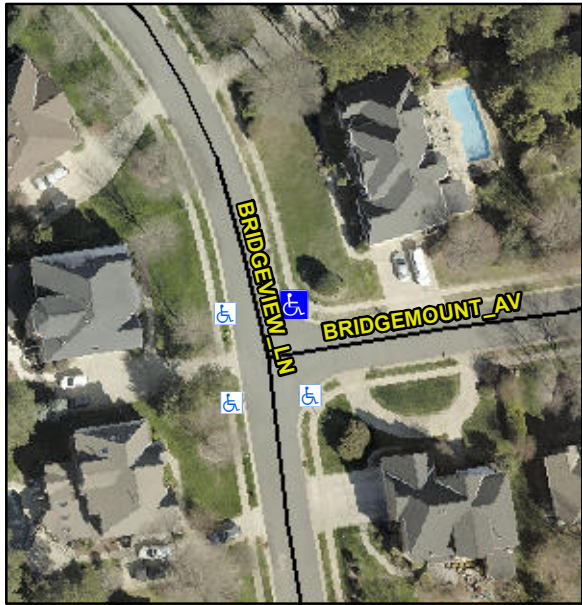
Compliance	Description	Data	Compliance	Description	Data
N/A	Ramp Length (in)	48.0	Yes	Ramp Slope (%)	7.1
No	Ramp Width (in)	40.0	No	Ramp XSlope (%)	7.2
N/A	Flare Type LT	N/A	N/A	Flare Type RT	N/A
N/A	Flare Slope LT (%)	N/A	N/A	Flare Slope RT (%)	N/A
N/A	Flare Traversable LT?	N/A	N/A	Flare Traversable RT?	N/A
N/A	Landing Length (in)	N/A	N/A	DWS Provided?	N/A
N/A	Landing Width (in)	N/A	N/A	DWS Contrast?	N/A
N/A	Landing Slope (%)	N/A	N/A	DWS Length (in)	N/A
N/A	Landing X Slope (%)	N/A	N/A	DWS Full Width?	N/A
N/A	Landing Curb? (Y/N)	N/A	N/A	DWS Offset (in)	N/A
N/A	Shared Landing?	N/A			
N/A	Gutter Ponding?	N/A	N/A	Gutter Slope (%)	N/A
N/A	Gutter Lip Ht (in)	N/A	N/A	Gutter X Slope (%)	N/A
N/A	Painted X Walk1?	No	N/A	Painted X Walk2?	No
	X Walk 1 Direction	To W		X Walk 2 Direction	To S
N/A	X Walk 1 Width (in)	N/A	N/A	X Walk 2 Width (in)	N/A
	X Walk 1 Slope (%)	0.4		X Walk 2 Slope (%)	5.4
	X Walk 1 X Slope (%)	4.5		X Walk 2 X Slope (%)	2.8

N/A	Ramp inside XWalk1?	N/A	N/A	Ramp inside XWalk2?	N/A
	Road Slope (%)	5.1	N/A	Clear Space?	N/A
	Road X Slope (%)	2.0	N/A	Clear Space to XWalk (in)	N/A
N/A	Any Obstructions?	N/A	N/A	Storm Grate/Utility Hazard?	N/A
	Obstruction Type			Storm Grate/Utility Type	
		N/A			N/A
			Yes	Surface Condition? (G/P)	Good

Possible Solutions:				
	Remove & Replace Curb Ramp With Two New Directional Ramps or Equivalent.				
	Surveyor Notes:				
	N/A				
	PROW/ADA:				
	Not Found, R304.5.1, R304.5.3				
Total Cost:		\$	3200.00
