Access Compliance Report Public Rights-of-Way (Curb Ramps)

Intersection ID: 10040992	Main Street: WALTON_RD	Cross Street: CHELVESTON_DR	Location: E
ADA ID: 6BEB89E7D8B2	Ramp Type: Directional1	Initial Pass/Fail: Pass	Overall Compliance: No Severity Score: 0.25

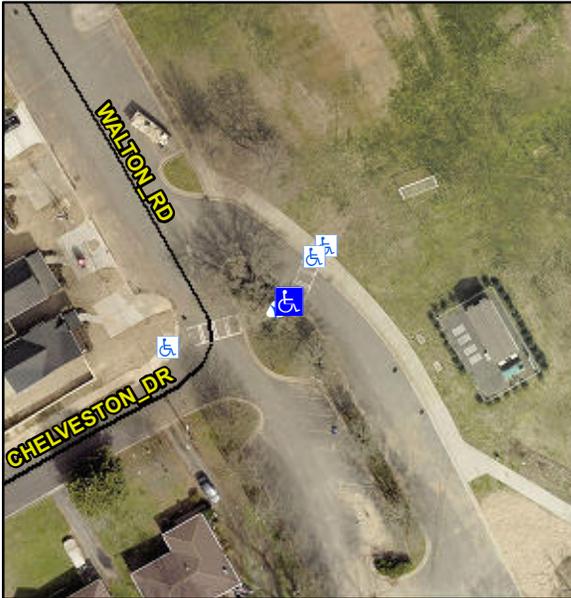
Surveyor Notes:
LOCATED ON ISLAND

Compliance	Description	Data	Compliance	Description	Data
N/A	Ramp Length (in)	177.0	Yes	Grade Break?	Yes
Yes	Ramp Width (in)	70.0	Yes	Grade Break Slope (%)	4.1
Yes	Ramp Slope (%)	3.8	Yes	Grade Break XSlope (%)	2.9
Yes	Ramp XSlope (%)	2.9			
Yes	Flare Type LT	N/A	Yes	Flare Type RT	N/A
N/A	Flare Slope LT (%)	N/A	N/A	Flare Slope RT (%)	N/A
N/A	Flare Traversable LT?	No	N/A	Flare Traversable RT?	No
Yes	Landing Length (in)	55.0	Yes	DWS Provided?	Yes
Yes	Landing Width (in)	70.0	Yes	DWS Contrast?	Yes
No	Landing Slope (%)	3.2	Yes	DWS Length (in)	24.0
No	Landing X Slope (%)	3.3	Yes	DWS Full Width?	Yes
N/A	Landing Curb? (Y/N)	N/A	Yes	DWS Offset LT (in)	36.0
N/A	Shared Landing?	Yes	Yes	DWS Offset RT (in)	1.0
Yes	Gutter Ponding?	No	Yes	Gutter Slope (%)	2.8
Yes	Gutter Lip Ht (in)	0.0	No	Gutter X Slope (%)	4.4
N/A	Painted X Walk1?	Yes		Road Slope (%)	1.4
	X Walk 1 Direction	To N		Road X Slope (%)	3.3
	X Walk 1 Width (in)	97.0		Clear Space?	Yes

X Walk 1 Slope (%)	1.4	N/A	Clear Space to XWalk (in)	N/A
	X Walk 1 X Slope (%)	3.3	Yes	Storm Grate/Utility Hazard?	No
Yes	Ramp inside XWalk1?	Yes		Storm Grate/Utility Type	
Yes	Any Obstructions?	No			N/A
	Obstruction Type		Yes	Surface Condition? (G/P)	Good
			N/A	Curb Slope (%)	6.5

Possible Solutions:
Remove & Replace Landing.
Remove & Replace Gutter.

PROW/ADA:
**R304.2.2-Perp, R304.3.2-Para,
 R304.5.3**
