Access Compliance Report

Public Rights-of-Way

(Curb Ramps)

Intersection ID: 45885	Main Street: ETHEL_CT	Cross Street: BEN_LIVINGSTON_RD	Location: S
ADA ID: 6BF063CB2814	Ramp Type: Perp	Initial Pass/Fail: Fail	Overall Compliance: No
		Severity Score: 37.5

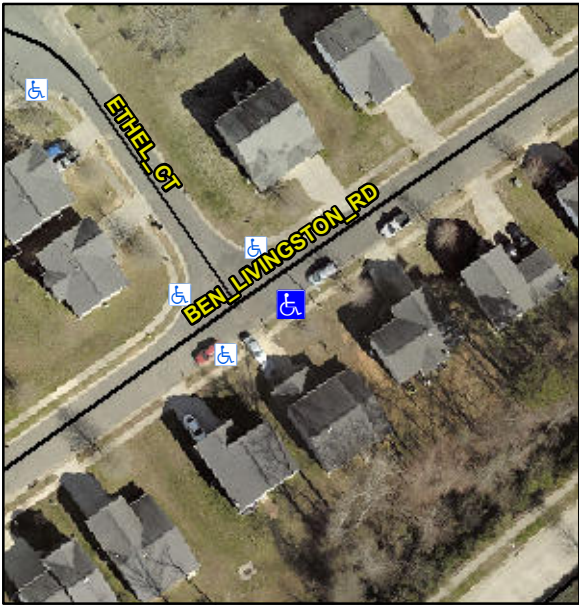
<div>Street 1 Name<div>BEN LIVINGSTON RD</div></div> <div>Stop Condition-Street 2<div>None</div></div> <div>Street 2 Name<div>N/A</div></div> <div>Stop Condition-Street 1<div>N/A</div></div>	Possible Solutions:		Compliance	Description	Data	Compliance	Description	Data
	Remove & Replace Entire Ramp.		N/A	Ramp Length (in)	48.0	No	Ramp Slope (%)	14.0
			Yes	Ramp Width (in)	48.0	No	Ramp XSlope (%)	5.4
			N/A	Flare Type LT	N/A	N/A	Flare Type RT	N/A
			N/A	Flare Slope LT (%)	N/A	N/A	Flare Slope RT (%)	N/A
			N/A	Flare Traversable LT?	N/A	N/A	Flare Traversable RT?	N/A
			N/A	Landing Length (in)	N/A	N/A	DWS Provided?	N/A
			N/A	Landing Width (in)	N/A	N/A	DWS Contrast?	N/A
			N/A	Landing Slope (%)	N/A	N/A	DWS Length (in)	N/A
			N/A	Landing X Slope (%)	N/A	N/A	DWS Full Width?	N/A
Surveyor Notes:		N/A	N/A	Landing Curb? (Y/N)	N/A	N/A	DWS Offset (in)	N/A

PROW/ADA:			N/A	Shared Landing?	N/A			
R304.2.2, R304.5.3			N/A	Gutter Ponding?	N/A	N/A	Gutter Slope (%)	N/A
			N/A	Gutter Lip Ht (in)	N/A	N/A	Gutter X Slope (%)	N/A
			N/A	Painted X Walk1?	No	N/A	Painted X Walk2?	N/A
				X Walk 1 Direction	To N		X Walk 2 Direction	N/A
			N/A	X Walk 1 Width (in)	N/A	N/A	X Walk 2 Width (in)	N/A
				X Walk 1 Slope (%)	3.4		X Walk 2 Slope (%)	N/A
				X Walk 1 X Slope (%)	6.2		X Walk 2 X Slope (%)	N/A
			N/A	Ramp inside XWalk1?	N/A	N/A	Ramp inside XWalk2?	N/A
				Road Slope (%)	N/A	N/A	Clear Space?	N/A
				Road X Slope (%)	N/A	N/A	Clear Space to XWalk (in)	N/A
			N/A	Any Obstructions?	N/A	N/A	Storm Grate/Utility Hazard?	N/A
				Obstruction Type			Storm Grate/Utility Type	
					N/A			N/A
						Yes	Surface Condition? (G/P)	Good
Total Cost:		\$	1850.00
