Access Compliance Report

Public Rights-of-Way

(Curb Ramps)

Intersection ID: 29171	Main Street: CHIEFTAIN_DR	Cross Street: COUGAR_HILL_CT	Location: SW
ADA ID: 6BFA0561B5FF	Ramp Type: Perp	Initial Pass/Fail: Fail	Overall Compliance: No
Severity Score: 21.25			
Codes/Mitigation Info/Possible Solution		Field Measurements/Component Compliance

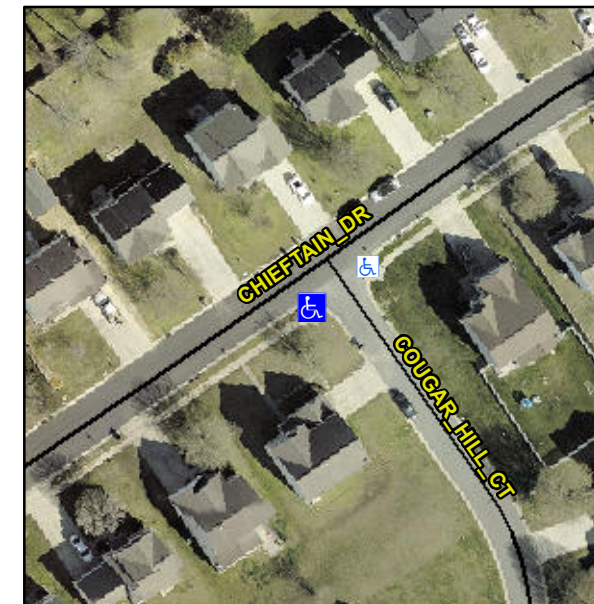
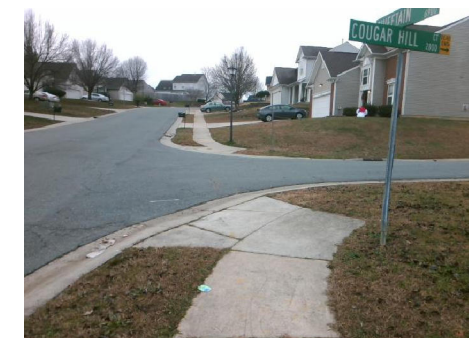
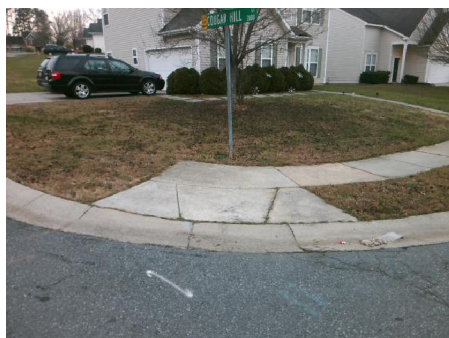
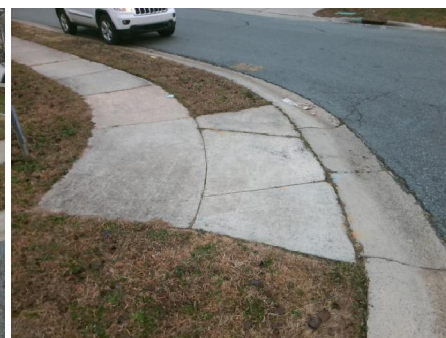
Not Found, R304.5.1, R304.5.3

Compliance	Description	Data	Compliance	Description	Data
N/A	Ramp Length (in)	46.0	Yes	Ramp Slope (%)	5.0
No	Ramp Width (in)	39.5	No	Ramp XSlope (%)	5.5
N/A	Flare Type LT	N/A	N/A	Flare Type RT	N/A
N/A	Flare Slope LT (%)	N/A	N/A	Flare Slope RT (%)	N/A
N/A	Flare Traversable LT?	N/A	N/A	Flare Traversable RT?	N/A
N/A	Landing Length (in)	N/A	N/A	DWS Provided?	N/A
N/A	Landing Width (in)	N/A	N/A	DWS Contrast?	N/A
N/A	Landing Slope (%)	N/A	N/A	DWS Length (in)	N/A
N/A	Landing X Slope (%)	N/A	N/A	DWS Full Width?	N/A
N/A	Landing Curb? (Y/N)	N/A	N/A	DWS Offset (in)	N/A
N/A	Shared Landing?	N/A			
N/A	Gutter Ponding?	N/A	N/A	Gutter Slope (%)	N/A
N/A	Gutter Lip Ht (in)	N/A	N/A	Gutter X Slope (%)	N/A
N/A	Painted X Walk1?	No	N/A	Painted X Walk2?	N/A
	X Walk 1 Direction	To NE		X Walk 2 Direction	N/A
N/A	X Walk 1 Width (in)	N/A	N/A	X Walk 2 Width (in)	N/A
	X Walk 1 Slope (%)	6.9		X Walk 2 Slope (%)	N/A
	X Walk 1 X Slope (%)	1.2		X Walk 2 X Slope (%)	N/A

N/A	Ramp inside XWalk1?	N/A	N/A	Ramp inside XWalk2?	N/A
	Road Slope (%)	N/A	N/A	Clear Space?	N/A
	Road X Slope (%)	N/A	N/A	Clear Space to XWalk (in)	N/A
N/A	Any Obstructions?	N/A	N/A	Storm Grate/Utility Hazard?	N/A
	Obstruction Type			Storm Grate/Utility Type	
		N/A			N/A
			Yes	Surface Condition? (G/P)	Good

Remove & Replace Entire Ramp.
