Access Compliance Report

Public Rights-of-Way

(Curb Ramps)

Intersection ID: 12508	Main Street: BELVEDERE_AV	Cross Street: CLUB_RD	Location: W
ADA ID: 6C0BF9E0197F	Ramp Type: Perp	Initial Pass/Fail: Fail	Overall Compliance: No
Severity Score: 21.25			
Codes/Mitigation Info/Possible Solution		Field Measurements/Component Compliance

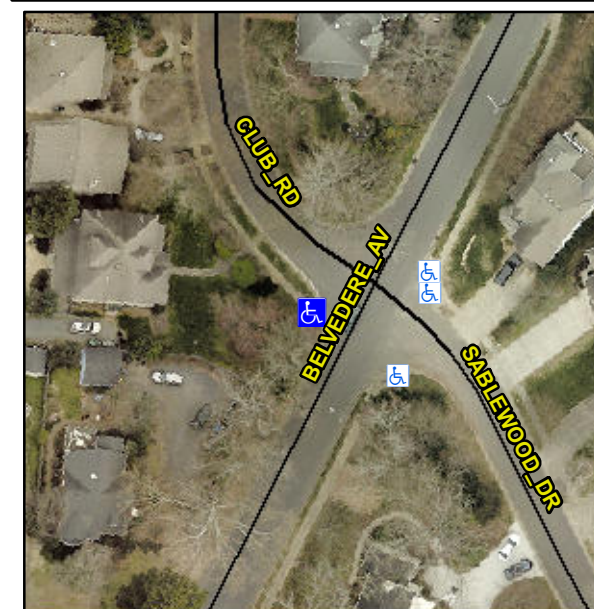
R304.5.1, R304.2.2

Compliance	Description	Data	Compliance	Description	Data
N/A	Ramp Length (in)	67.5	No	Ramp Slope (%)	9.4
No	Ramp Width (in)	46.0	Yes	Ramp XSlope (%)	1.2
N/A	Flare Type LT	N/A	N/A	Flare Type RT	N/A
N/A	Flare Slope LT (%)	N/A	N/A	Flare Slope RT (%)	N/A
N/A	Flare Traversable LT?	N/A	N/A	Flare Traversable RT?	N/A
N/A	Landing Length (in)	N/A	N/A	DWS Provided?	N/A
N/A	Landing Width (in)	N/A	N/A	DWS Contrast?	N/A
N/A	Landing Slope (%)	N/A	N/A	DWS Length (in)	N/A
N/A	Landing X Slope (%)	N/A	N/A	DWS Full Width?	N/A
N/A	Landing Curb? (Y/N)	N/A	N/A	DWS Offset (in)	N/A
N/A	Shared Landing?	N/A			
N/A	Gutter Ponding?	N/A	N/A	Gutter Slope (%)	N/A
N/A	Gutter Lip Ht (in)	1.0	N/A	Gutter X Slope (%)	N/A
N/A	Painted X Walk1?	No	N/A	Painted X Walk2?	N/A
	X Walk 1 Direction	To SE		X Walk 2 Direction	N/A
N/A	X Walk 1 Width (in)	N/A	N/A	X Walk 2 Width (in)	N/A
	X Walk 1 Slope (%)	1.4		X Walk 2 Slope (%)	N/A
	X Walk 1 X Slope (%)	2.2		X Walk 2 X Slope (%)	N/A

Possible Solutions:

Remove & Replace Entire Ramp.
