Access Compliance Report

Public Rights-of-Way

(Curb Ramps)

Intersection ID: 45786	Main Street: LONG_HILL_DR	Cross Street: SHELLVIEW_LN	Location: S
ADA ID: 6C171CA5C62E	Ramp Type: BlendTrans1	Initial Pass/Fail: Fail	Overall Compliance: No
		Severity Score: 10

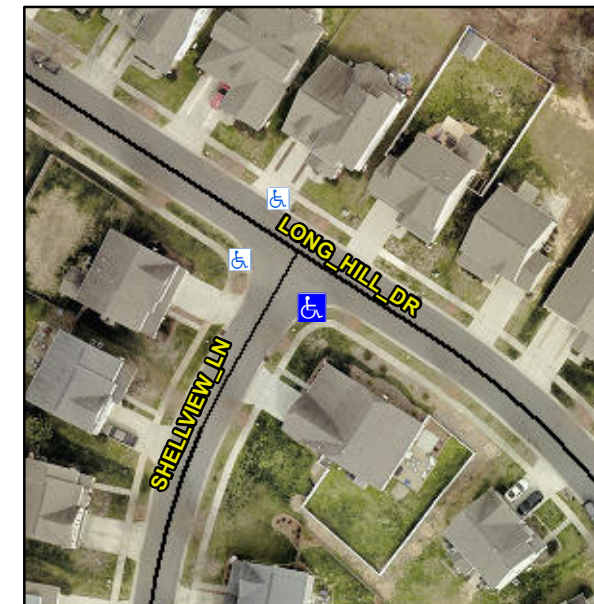
Not Found, R304.5.1, R304.5.3

Compliance	Description	Data	Compliance	Description	Data
N/A	Ramp Length (in)	70.0	Yes	BlendTrans Slope (%)	3.0
No	Ramp Width (in)	47.5	No	BlendTrans XSlope (%)	4.0
N/A	Flare Type LT	N/A	N/A	Flare Type RT	N/A
N/A	Flare Slope LT (%)	N/A	N/A	Flare Slope RT (%)	N/A
N/A	Flare Traversable LT?	N/A	N/A	Flare Traversable RT?	N/A
N/A	Landing Length (in)	N/A	N/A	DWS Provided?	N/A
N/A	Landing Width (in)	N/A	N/A	DWS Contrast?	N/A
N/A	Landing Slope (%)	N/A	N/A	DWS Length (in)	N/A
N/A	Landing X Slope (%)	N/A	N/A	DWS Full Width?	N/A
N/A	Landing Curb? (Y/N)	N/A	N/A	DWS Offset (in)	N/A
N/A	Shared Landing?	N/A			
N/A	Gutter Ponding?	N/A	N/A	Gutter Slope (%)	N/A
N/A	Gutter Lip Ht (in)	N/A	N/A	Gutter X Slope (%)	N/A
N/A	Painted X Walk1?	No	N/A	Painted X Walk2?	No
	X Walk 1 Direction	To NE		X Walk 2 Direction	To NW
	X Walk 1 Width (in)	N/A		X Walk 2 Width (in)	N/A
	X Walk 1 Slope (%)	1.0		X Walk 2 Slope (%)	4.4
	X Walk 1 X Slope (%)	2.7		X Walk 2 X Slope (%)	0.2

N/A	Ramp inside XWalk1?	N/A	N/A	Ramp inside XWalk2?	N/A
	Road Slope (%)	3.5		Clear Space?	N/A
	Road X Slope (%)	3.0	N/A	Clear Space to XWalk (in)	N/A
N/A	Any Obstructions?	N/A	N/A	Storm Grate/Utility Hazard?	N/A
	Obstruction Type			Storm Grate/Utility Type	
		N/A			N/A
			Yes	Surface Condition? (G/P)	Good
			No	Curb Slope (%)	20.6

Remove & Replace Curb Ramp With Two New Directional Ramps or Equivalent.

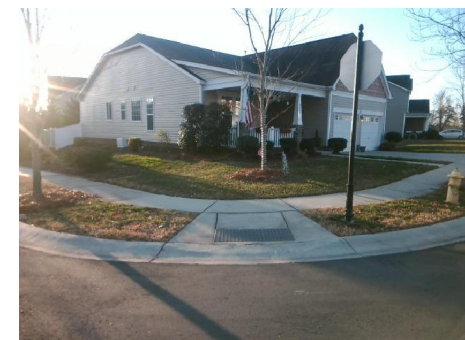
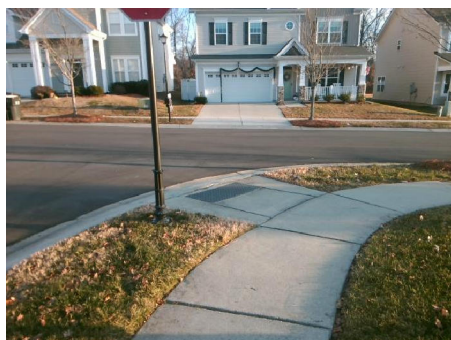
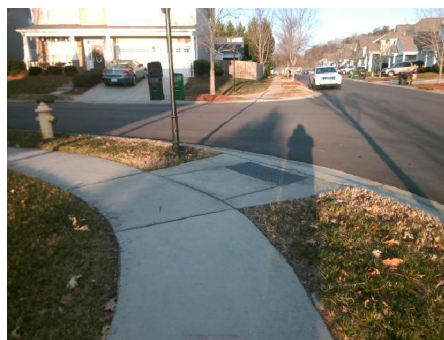
Street 1 Name LONG HILL DR
 Stop Condition-Street 1 None
 Street 2 Name SHELLVIEW LN
 Stop Condition-Street 2 StopSign
