Access Compliance Report

Public Rights-of-Way

(Curb Ramps)

Intersection ID: 10888	Main Street: DRUMMOND_AV	Cross Street: PINCKNEY_AV	Location: S
ADA ID: 6C3C93D883D3	Ramp Type: Perp	Initial Pass/Fail: Fail	Overall Compliance: No
Severity Score: 61.25			
Codes/Mitigation Info/Possible Solution		Field Measurements/Component Compliance

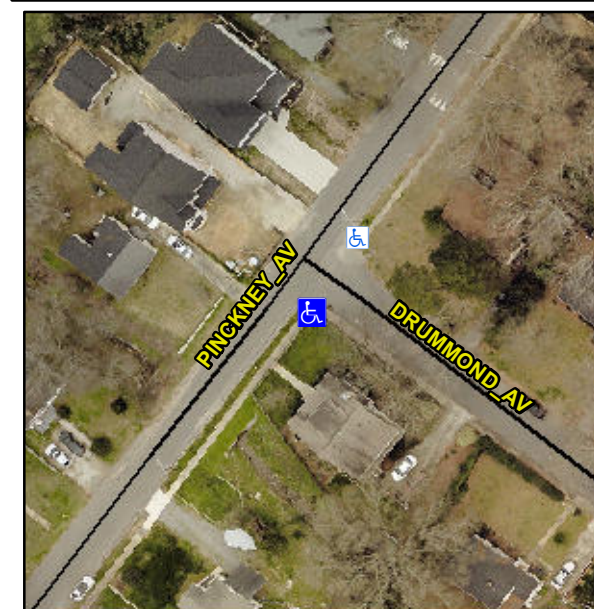
Not Found, R304.5.1, R304.2.2, R304.5.3

Compliance	Description	Data	Compliance	Description	Data
N/A	Ramp Length (in)	41.0	No	Ramp Slope (%)	15.8
No	Ramp Width (in)	25.0	No	Ramp XSlope (%)	2.3
N/A	Flare Type LT	N/A	N/A	Flare Type RT	N/A
N/A	Flare Slope LT (%)	N/A	N/A	Flare Slope RT (%)	N/A
N/A	Flare Traversable LT?	N/A	N/A	Flare Traversable RT?	N/A
N/A	Landing Length (in)	N/A	N/A	DWS Provided?	N/A
N/A	Landing Width (in)	N/A	N/A	DWS Contrast?	N/A
N/A	Landing Slope (%)	N/A	N/A	DWS Length (in)	N/A
N/A	Landing X Slope (%)	N/A	N/A	DWS Full Width?	N/A
N/A	Landing Curb? (Y/N)	N/A	N/A	DWS Offset (in)	N/A
N/A	Shared Landing?	N/A			
N/A	Gutter Ponding?	N/A	N/A	Gutter Slope (%)	N/A
N/A	Gutter Lip Ht (in)	N/A	N/A	Gutter X Slope (%)	N/A
N/A	Painted X Walk1?	No	N/A	Painted X Walk2?	N/A
	X Walk 1 Direction	To NE		X Walk 2 Direction	N/A
N/A	X Walk 1 Width (in)	N/A	N/A	X Walk 2 Width (in)	N/A
	X Walk 1 Slope (%)	3.6		X Walk 2 Slope (%)	N/A
	X Walk 1 X Slope (%)	3.7		X Walk 2 X Slope (%)	N/A

N/A	Ramp inside XWalk1?	N/A	N/A	Ramp inside XWalk2?	N/A
	Road Slope (%)	N/A	N/A	Clear Space?	N/A
	Road X Slope (%)	N/A	N/A	Clear Space to XWalk (in)	N/A
N/A	Any Obstructions?	N/A	N/A	Storm Grate/Utility Hazard?	N/A
	Obstruction Type			Storm Grate/Utility Type	
		N/A			N/A
			Yes	Surface Condition? (G/P)	Good

Remove & Replace Entire Ramp.
