Access Compliance Report

Public Rights-of-Way

(Curb Ramps)

Intersection ID: 20540	Main Street: FAIRVIEW_RD	Cross Street: VALENCIA_TR	Location: NW
ADA ID: 6C3F146A4A7A	Ramp Type: Perp	Initial Pass/Fail: Fail	Overall Compliance: No
Severity Score: 13.75			
Codes/Mitigation Info/Possible Solution		Field Measurements/Component Compliance

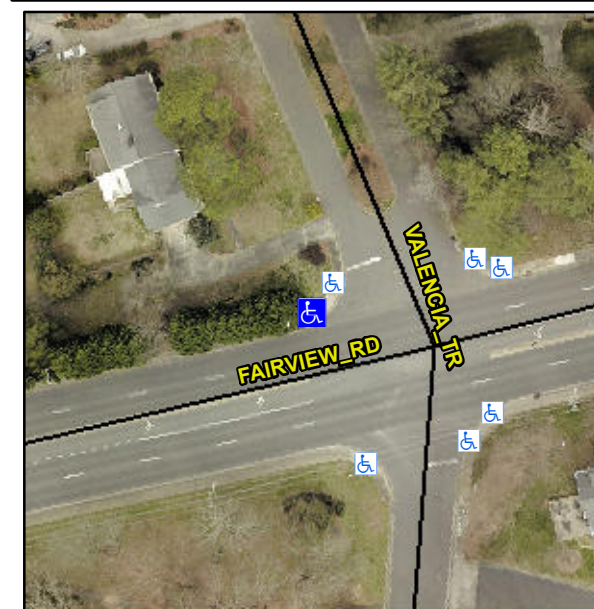
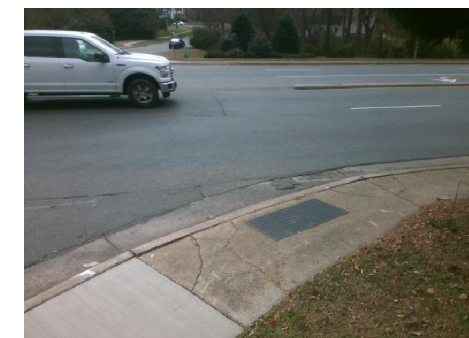
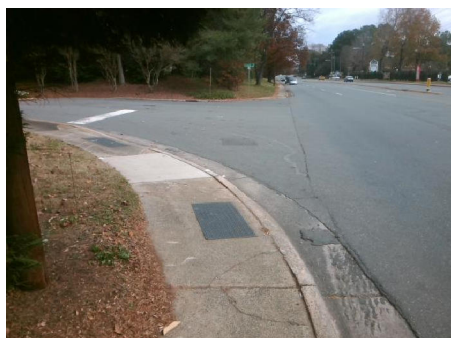
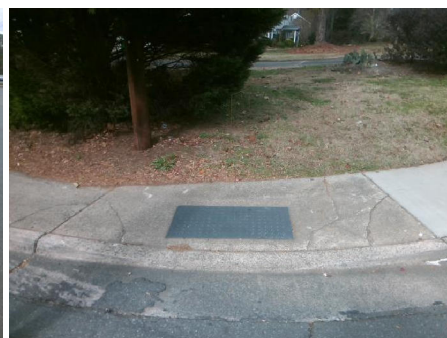
Not Found, R304.2.2, R304.5.3

Compliance	Description	Data	Compliance	Description	Data
N/A	Ramp Length (in)	57.0	No	Ramp Slope (%)	8.7
Yes	Ramp Width (in)	48.0	No	Ramp XSlope (%)	4.7
N/A	Flare Type LT	N/A	N/A	Flare Type RT	N/A
N/A	Flare Slope LT (%)	N/A	N/A	Flare Slope RT (%)	N/A
N/A	Flare Traversable LT?	N/A	N/A	Flare Traversable RT?	N/A
N/A	Landing Length (in)	N/A	N/A	DWS Provided?	N/A
N/A	Landing Width (in)	N/A	N/A	DWS Contrast?	N/A
N/A	Landing Slope (%)	N/A	N/A	DWS Length (in)	N/A
N/A	Landing X Slope (%)	N/A	N/A	DWS Full Width?	N/A
N/A	Landing Curb? (Y/N)	N/A	N/A	DWS Offset (in)	N/A
N/A	Shared Landing?	N/A			
N/A	Gutter Ponding?	N/A	N/A	Gutter Slope (%)	N/A
N/A	Gutter Lip Ht (in)	N/A	N/A	Gutter X Slope (%)	N/A
N/A	Painted X Walk1?	No	N/A	Painted X Walk2?	N/A
	X Walk 1 Direction	To SE		X Walk 2 Direction	N/A
N/A	X Walk 1 Width (in)	N/A	N/A	X Walk 2 Width (in)	N/A
	X Walk 1 Slope (%)	3.8		X Walk 2 Slope (%)	N/A
	X Walk 1 X Slope (%)	2.6		X Walk 2 X Slope (%)	N/A

N/A	Ramp inside XWalk1?	N/A	N/A	Ramp inside XWalk2?	N/A
	Road Slope (%)	N/A	N/A	Clear Space?	N/A
	Road X Slope (%)	N/A	N/A	Clear Space to XWalk (in)	N/A
N/A	Any Obstructions?	N/A	N/A	Storm Grate/Utility Hazard?	N/A
	Obstruction Type			Storm Grate/Utility Type	
		N/A			N/A
			Yes	Surface Condition? (G/P)	Good

Remove & Replace Entire Ramp.

Total Cost: \$ 1850.00
