Access Compliance Report

Public Rights-of-Way

(Curb Ramps)

Intersection ID: 9132	Main Street: BARLOWE_RD	Cross Street: TILLMAN_RD	Location: SE
ADA ID: 6C3FD7FC54F5	Ramp Type: Perp	Initial Pass/Fail: Fail	Overall Compliance: No
		Severity Score: 8.75

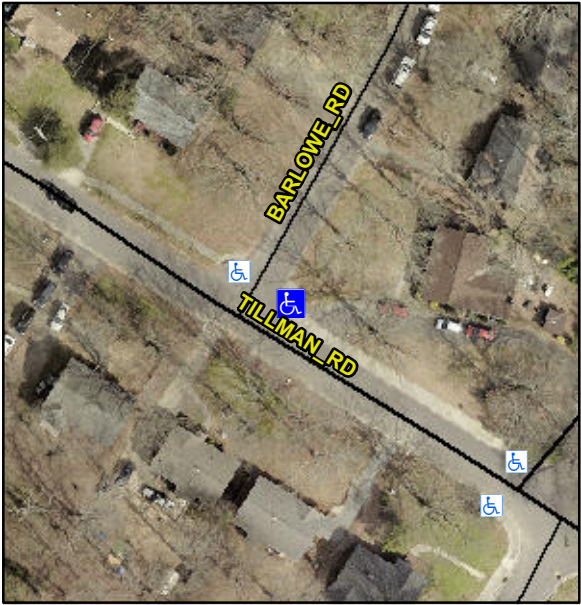
Possible Solutions:		Compliance	Description	Data
	Remove & Replace Entire Ramp.		Yes	Ramp Length (in)	73.0
			No	Ramp Width (in)	47.5
			N/A	Flare Type LT	N/A
			N/A	Flare Slope LT (%)	N/A
			N/A	Flare Traversable LT?	N/A
			N/A	Landing Length (in)	N/A
			N/A	Landing Width (in)	N/A
			N/A	Landing Slope (%)	N/A
			N/A	Landing X Slope (%)	N/A
<p>Surveyor Notes:</p> <p>N/A</p> <p>PROW/ADA:</p> <p>Not Found, R304.5.1</p>			N/A	Flare Type RT	N/A
			N/A	Flare Slope RT (%)	N/A
			N/A	Flare Traversable RT?	N/A
			N/A	DWS Provided?	N/A
			N/A	DWS Contrast?	N/A
			N/A	DWS Length (in)	N/A
			N/A	DWS Full Width?	N/A
			N/A	DWS Offset (in)	N/A
			N/A	Shared Landing?	N/A
			N/A	Gutter Ponding?	N/A
			N/A	Gutter Lip Ht (in)	N/A
			N/A	Painted X Walk1?	No
				X Walk 1 Direction	To NW
			N/A	X Walk 1 Width (in)	N/A
				X Walk 1 Slope (%)	2.6
				X Walk 1 X Slope (%)	2.0

N/A	Ramp inside XWalk1?	N/A
			N/A	Road Slope (%)	N/A
			N/A	Road X Slope (%)	N/A
			N/A	Any Obstructions?	N/A
				Obstruction Type	
			N/A		
			N/A		
			N/A		
			N/A		
			N/A		
			N/A		
			N/A		
			N/A		
			N/A		
Total Cost:		\$ 1850.00			
			Yes	Surface Condition? (G/P)	Good
