# Access Compliance Report

## Public Rights-of-Way

### (Curb Ramps)

Intersection ID: 45828	Main Street: CHRISTENBURY_HILLS_LN	Cross Street: GRAYS_RIDGE_DR	Location: NW
ADA ID: 6C407AF824B9	Ramp Type: PerpDiag	Initial Pass/Fail: Fail	Overall Compliance: No
Severity Score: 30			
Codes/Mitigation Info/Possible Solution		Field Measurements/Component Compliance

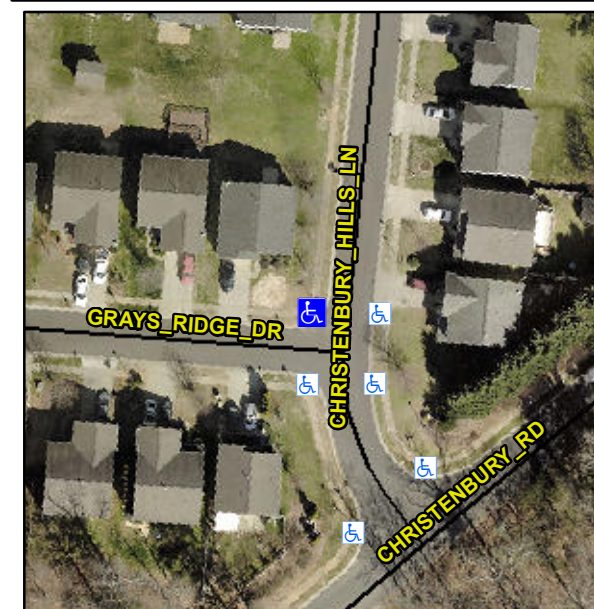
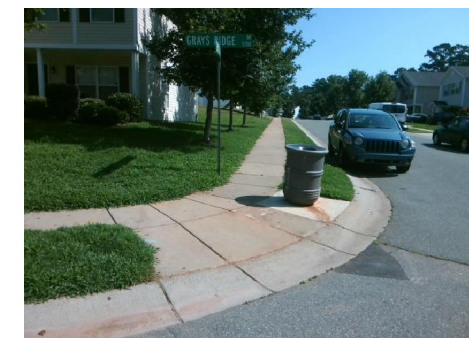
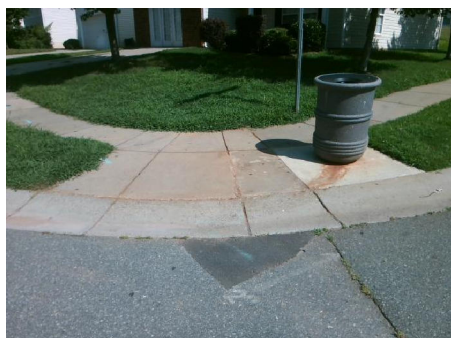
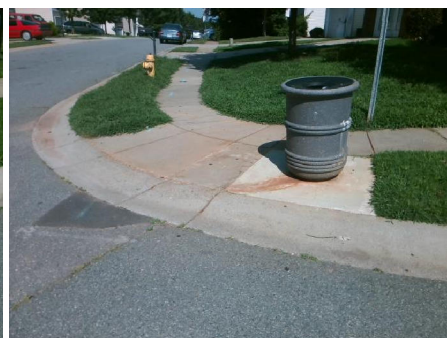
**Not Found, R304.5.1, R304.2.2**

Compliance	Description	Data	Compliance	Description	Data
N/A	Ramp Length (in)	47.5	No	Ramp Slope (%)	10.5
No	Ramp Width (in)	34.0	Yes	Ramp XSlope (%)	1.7
N/A	Flare Type LT	N/A	N/A	Flare Type RT	N/A
N/A	Flare Slope LT (%)	N/A	N/A	Flare Slope RT (%)	N/A
N/A	Flare Traversable LT?	N/A	N/A	Flare Traversable RT?	N/A
N/A	Landing Length (in)	N/A	N/A	DWS Provided?	N/A
N/A	Landing Width (in)	N/A	N/A	DWS Contrast?	N/A
N/A	Landing Slope (%)	N/A	N/A	DWS Length (in)	N/A
N/A	Landing X Slope (%)	N/A	N/A	DWS Full Width?	N/A
N/A	Landing Curb? (Y/N)	N/A	N/A	DWS Offset (in)	N/A
N/A	Shared Landing?	N/A			
N/A	Gutter Ponding?	N/A	N/A	Gutter Slope (%)	N/A
N/A	Gutter Lip Ht (in)	N/A	N/A	Gutter X Slope (%)	N/A
N/A	Painted X Walk1?	No	N/A	Painted X Walk2?	No
	X Walk 1 Direction	To S		X Walk 2 Direction	To E
N/A	X Walk 1 Width (in)	N/A	N/A	X Walk 2 Width (in)	N/A
	X Walk 1 Slope (%)	3.5		X Walk 2 Slope (%)	0.4
	X Walk 1 X Slope (%)	0.2		X Walk 2 X Slope (%)	2.6

N/A	Ramp inside XWalk1?	N/A	N/A	Ramp inside XWalk2?	N/A
	Road Slope (%)	1.6	N/A	Clear Space?	N/A
	Road X Slope (%)	1.6	N/A	Clear Space to XWalk (in)	N/A
N/A	Any Obstructions?	N/A	N/A	Storm Grate/Utility Hazard?	N/A
	Obstruction Type			Storm Grate/Utility Type	
		N/A			N/A
			Yes	Surface Condition? (G/P)	Good

**Remove & Replace Curb Ramp With Two New Directional Ramps or Equivalent.**
