# Access Compliance Report

## Public Rights-of-Way

### (Curb Ramps)

| Intersection ID: 23574 | Main Street: CARMEL_RD | Cross Street: QUAIL_HOLLOW_RD | Location: SW |

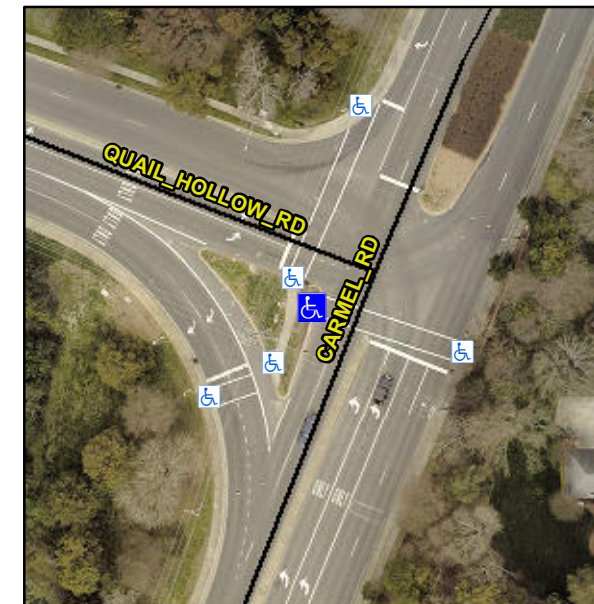
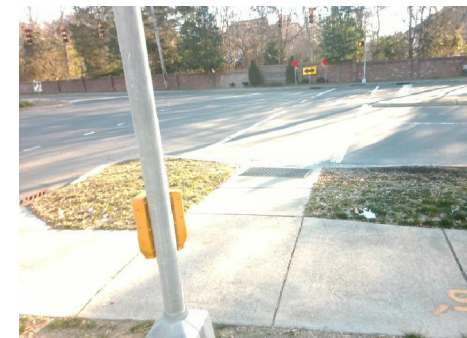
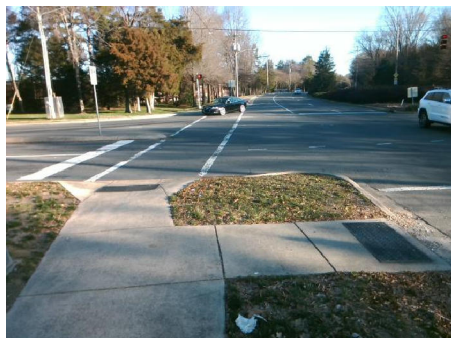
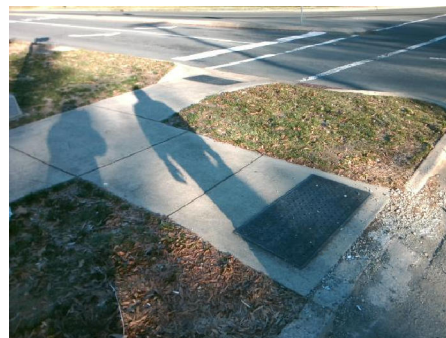
**DAMAGED GTR**

| Compliance | Description | Data | Compliance | Description | Data |
|---|---|---|---|---|---|
| No | Landing Slope (%) | 3.8 | Yes | DWS Length (in) | 24.0 |
| Yes | Landing X Slope (%) | 1.5 | No | DWS Full Width? | No |
| N/A | Landing Curb? (Y/N) | No | No | DWS Offset (in) | 6.0 |

**Remove & Replace Curb Ramp With Two New Directional Ramps or Equivalent.**

**R304.2.2-Perp, R304.3.2-Para, R305.1.4, R305.2**
