# Access Compliance Report

## Public Rights-of-Way (Curb Ramps)

| Intersection ID: 11556 | Main Street: HARRILL_ST | Cross Street: PARKWOOD_AV | Location: NW |
| ADA ID: 6C4B6D77EFDC | Ramp Type: PerpDiag | Initial Pass/Fail: Fail | Overall Compliance: No |

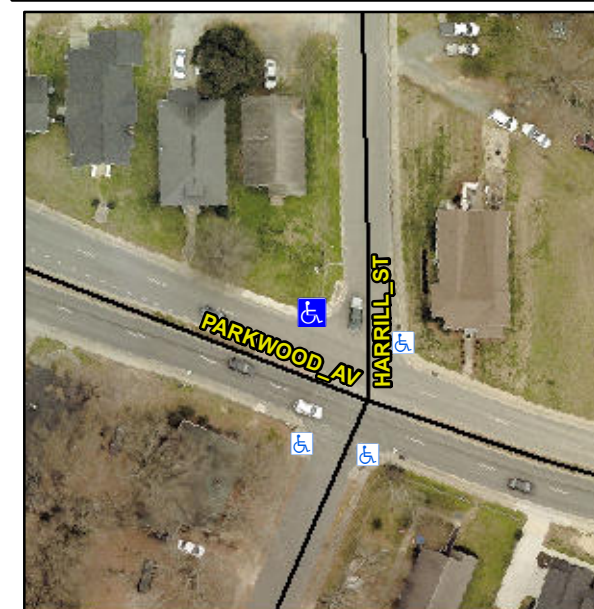
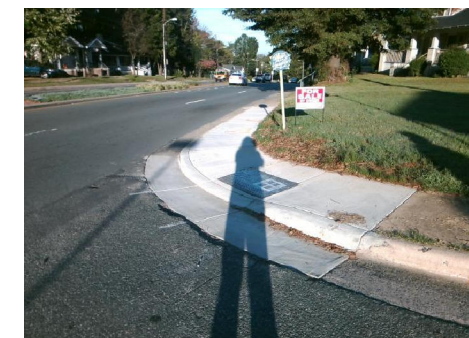
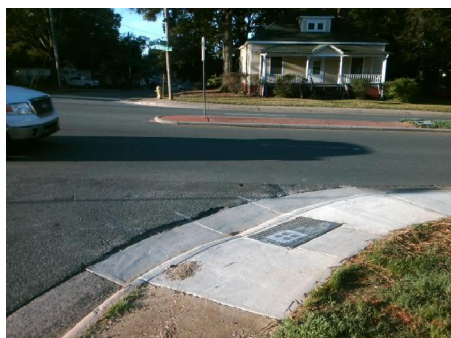
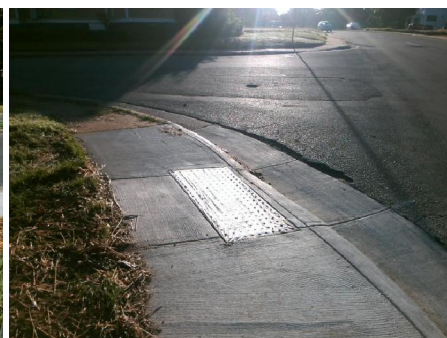
**Not Found, R304.5.1, R304.2.2, R304.5.3**

| Compliance | Description | Data | Compliance | Description | Data |
|---|---|---|---|---|---|
| N/A | Ramp Length (in) | 55.5 | No | Ramp Slope (%) | 13.0 |
| No | Ramp Width (in) | 38.5 | No | Ramp XSlope (%) | 9.3 |

**Remove & Replace Curb Ramp With Two New Directional Ramps or Equivalent.**
