Intersection ID: 24836		Main Street: PARK_CROSSING_DR		Cross Street: WELWYN_LN		Location:		NE	
ADA ID: 6C5A0E2C7BC2		Ramp Type: PerpDiag		Initial Pass/Fail: Fail		Overall Compliance: No		Severity Score: 12.5	
Codes/Mitigation Info/Possible Solution				Field Measurements/Component Compliance

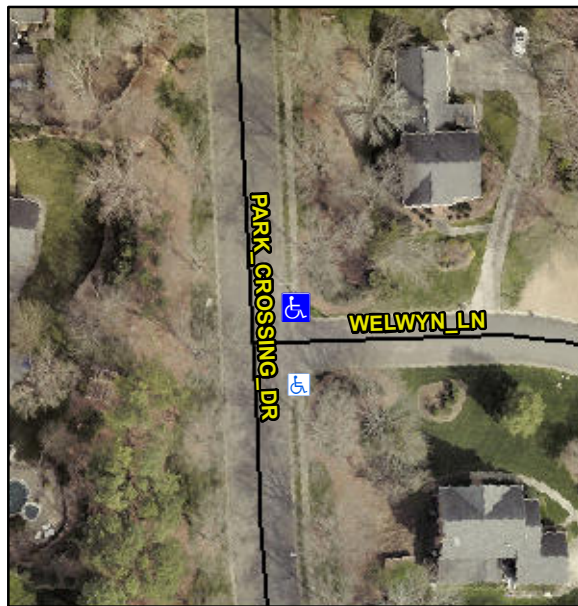
<p>Possible Solutions:</p> <p>Remove & Replace Curb Ramp With Two New Directional Ramps or Equivalent.</p> <p>Surveyor Notes:</p> <p>N/A</p> <p>PROW/ADA:</p> <p>Not Found, R304.2.2</p>				Compliance	Description	Data	Compliance	Description	Data
				N/A	Ramp Length (in)	34.0	No	Ramp Slope (%)	9.2
				Yes	Ramp Width (in)	48.0	Yes	Ramp XSlope (%)	1.4
				N/A	Flare Type LT	N/A	N/A	Flare Type RT	N/A
				N/A	Flare Slope LT (%)	N/A	N/A	Flare Slope RT (%)	N/A
				N/A	Flare Traversable LT?	N/A	N/A	Flare Traversable RT?	N/A
				N/A	Landing Length (in)	N/A	N/A	DWS Provided?	N/A
				N/A	Landing Width (in)	N/A	N/A	DWS Contrast?	N/A

N/A	Landing Slope (%)	N/A	N/A	DWS Length (in)	N/A
				N/A	Landing X Slope (%)	N/A	N/A	DWS Full Width?	N/A
				N/A	Landing Curb? (Y/N)	N/A	N/A	DWS Offset (in)	N/A
				N/A	Shared Landing?	N/A			
				N/A	Gutter Ponding?	N/A	N/A	Gutter Slope (%)	N/A
				N/A	Gutter Lip Ht (in)	N/A	N/A	Gutter X Slope (%)	N/A
				N/A	Painted X Walk1?	No	N/A	Painted X Walk2?	No
					X Walk 1 Direction	To W		X Walk 2 Direction	To S
				N/A	X Walk 1 Width (in)	N/A	N/A	X Walk 2 Width (in)	N/A
					X Walk 1 Slope (%)	2.4		X Walk 2 Slope (%)	0.5
					X Walk 1 X Slope (%)	0.3		X Walk 2 X Slope (%)	3.2
				N/A	Ramp inside XWalk1?	N/A	N/A	Ramp inside XWalk2?	N/A
					Road Slope (%)	1.6	N/A	Clear Space?	N/A
					Road X Slope (%)	1.2	N/A	Clear Space to XWalk (in)	N/A
				N/A	Any Obstructions?	N/A	N/A	Storm Grate/Utility Hazard?	N/A
					Obstruction Type			Storm Grate/Utility Type	
						N/A			N/A
							Yes	Surface Condition? (G/P)	Good
