Intersection ID: 43735	Main Street: BELMONT_WALK_WY	Cross Street: BRIDGEVIEW_LN	Location:	NE
ADA ID: 6C5BF0420490	Ramp Type: Perp	Initial Pass/Fail: Fail	Overall Compliance: No	Severity Score: 21.25

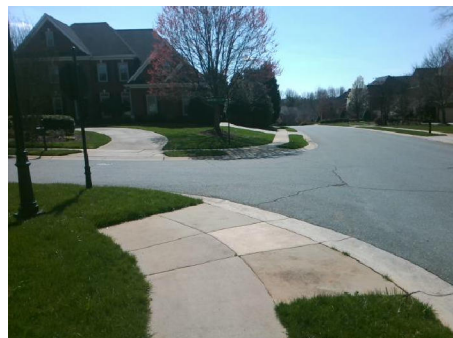
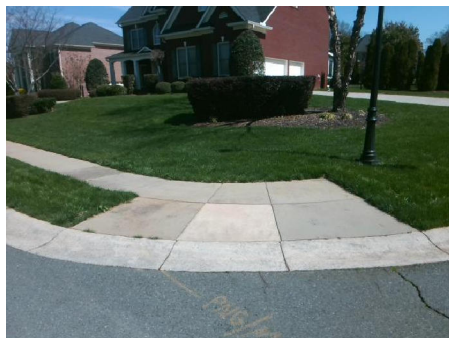
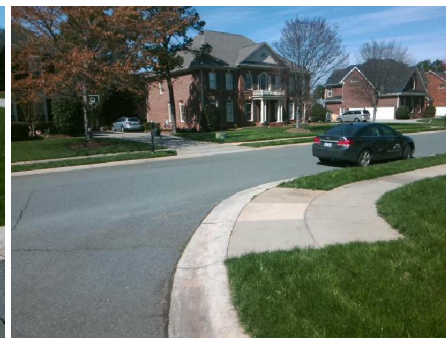
**Not Found, R304.5.1, R304.2.2**

Compliance	Description	Data	Compliance	Description	Data
N/A	Ramp Length (in)	47.5	No	Ramp Slope (%)	8.8
No	Ramp Width (in)	39.5	Yes	Ramp XSlope (%)	0.7
N/A	Flare Type LT	N/A	N/A	Flare Type RT	N/A
N/A	Flare Slope LT (%)	N/A	N/A	Flare Slope RT (%)	N/A
N/A	Flare Traversable LT?	N/A	N/A	Flare Traversable RT?	N/A
N/A	Landing Length (in)	N/A	N/A	DWS Provided?	N/A
N/A	Landing Width (in)	N/A	N/A	DWS Contrast?	N/A
N/A	Landing Slope (%)	N/A	N/A	DWS Length (in)	N/A
N/A	Landing X Slope (%)	N/A	N/A	DWS Full Width?	N/A
N/A	Landing Curb? (Y/N)	N/A	N/A	DWS Offset (in)	N/A
N/A	Shared Landing?	N/A			
N/A	Gutter Ponding?	N/A	N/A	Gutter Slope (%)	N/A
N/A	Gutter Lip Ht (in)	N/A	N/A	Gutter X Slope (%)	N/A
N/A	Painted X Walk1?	No	N/A	Painted X Walk2?	N/A
	X Walk 1 Direction	To S		X Walk 2 Direction	N/A
N/A	X Walk 1 Width (in)	N/A	N/A	X Walk 2 Width (in)	N/A
	X Walk 1 Slope (%)	0.6		X Walk 2 Slope (%)	N/A
	X Walk 1 X Slope (%)	0.7		X Walk 2 X Slope (%)	N/A

### Remove & Replace Entire Ramp.
