Access Compliance Report

Public Rights-of-Way

(Curb Ramps)

Intersection ID: N/A	Main Street: PROVIDENCE_RD	Cross Street: OUTER_BRIDGE_LN	Location: NE
ADA ID: 6C638B84D6D4	Ramp Type: Perp	Initial Pass/Fail: Fail	Overall Compliance: No
Codes/Mitigation Info/Possible Solution		Field Measurements/Component Compliance	
Severity Score: 21.25

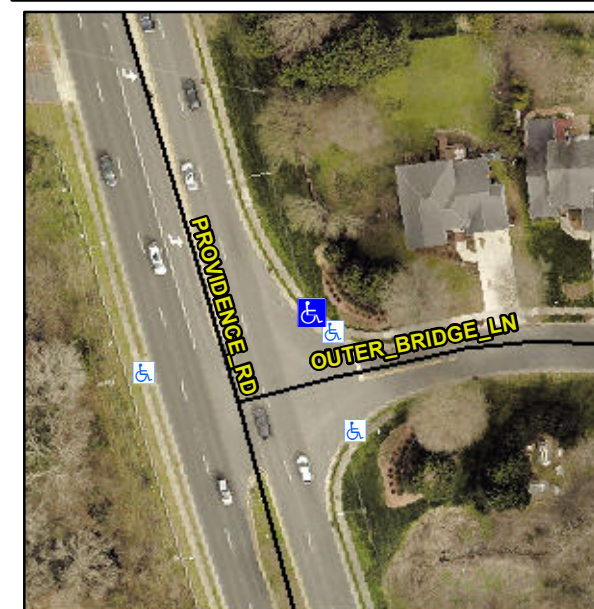
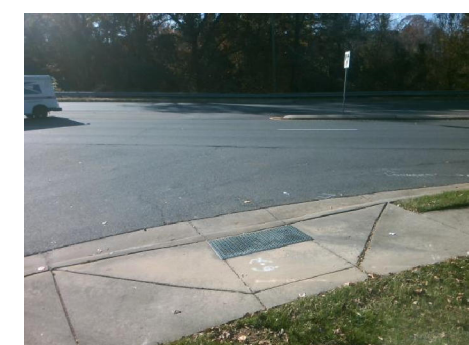
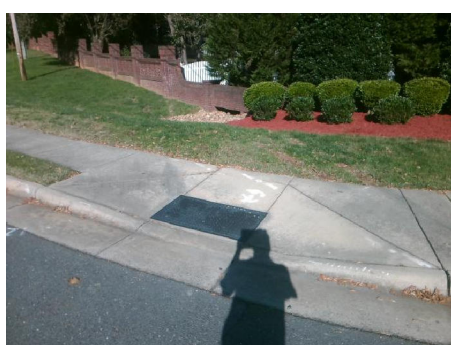
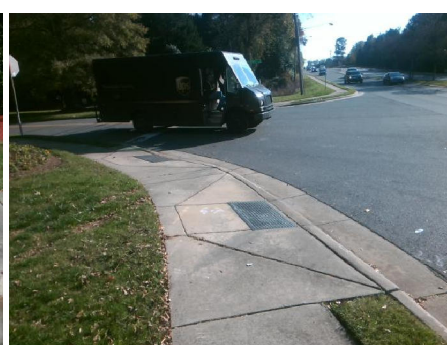
R304.5.1, R304.2.2

Compliance	Description	Data	Compliance	Description	Data
N/A	Ramp Length (in)	72.0	No	Ramp Slope (%)	9.3
No	Ramp Width (in)	45.0	Yes	Ramp XSlope (%)	1.1
N/A	Flare Type LT	N/A	N/A	Flare Type RT	N/A
N/A	Flare Slope LT (%)	N/A	N/A	Flare Slope RT (%)	N/A
N/A	Flare Traversable LT?	N/A	N/A	Flare Traversable RT?	N/A
N/A	Landing Length (in)	N/A	N/A	DWS Provided?	N/A
N/A	Landing Width (in)	N/A	N/A	DWS Contrast?	N/A
N/A	Landing Slope (%)	N/A	N/A	DWS Length (in)	N/A
N/A	Landing X Slope (%)	N/A	N/A	DWS Full Width?	N/A
N/A	Landing Curb? (Y/N)	N/A	N/A	DWS Offset (in)	N/A
N/A	Shared Landing?	N/A			
N/A	Gutter Ponding?	N/A	N/A	Gutter Slope (%)	N/A
N/A	Gutter Lip Ht (in)	N/A	N/A	Gutter X Slope (%)	N/A
N/A	Painted X Walk1?	No	N/A	Painted X Walk2?	N/A
	X Walk 1 Direction	To W		X Walk 2 Direction	N/A
N/A	X Walk 1 Width (in)	N/A	N/A	X Walk 2 Width (in)	N/A
	X Walk 1 Slope (%)	1.3		X Walk 2 Slope (%)	N/A
	X Walk 1 X Slope (%)	0.1		X Walk 2 X Slope (%)	N/A

N/A	Ramp inside XWalk1?	N/A	N/A	Ramp inside XWalk2?	N/A
	Road Slope (%)	N/A	N/A	Clear Space?	N/A
	Road X Slope (%)	N/A	N/A	Clear Space to XWalk (in)	N/A
N/A	Any Obstructions?	N/A	N/A	Storm Grate/Utility Hazard?	N/A
	Obstruction Type			Storm Grate/Utility Type	
		N/A			N/A
			Yes	Surface Condition? (G/P)	Good

Remove & Replace Entire Ramp.
