Access Compliance Report Public Rights-of-Way (Curb Ramps)

Intersection ID: 48366Main Street:WHEATFIELD_RDCross Street:SULKY_PLOUGH_RDLocation:NWADA ID: 6C6EB36E23BCRamp Type:PerpDiagInitial Pass/Fail:FailOverall Compliance:NoSeverity Score:1.25

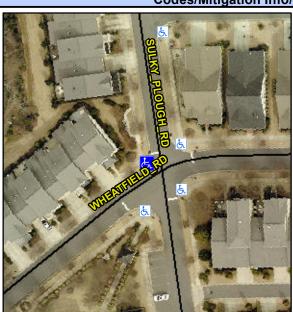
Field Measurements/Component Compliance							
	Comp	liance Description	Data	Comp	liance Description	Data	
	N/A	Ramp Length (in)	48.0	Yes	Ramp Slope (%)	6.4	
	Yes	Ramp Width (in)	48.0	No	Ramp XSlope (%)	2.3	
	N/A	Flare Type LT	N/A	N/A	Flare Type RT	N/A	
	N/A	Flare Slope LT (%)	N/A	N/A	Flare Slope RT (%)	N/A	
	N/A	Flare Traversable LT?	N/A	N/A	Flare Traversable RT?	N/A	
	N/A	Landing Length (in)	N/A	N/A	DWS Provided?	N/A	
	N/A	Landing Width (in)	N/A	N/A	DWS Contrast?	N/A	
	N/A	Landing Slope (%)	N/A	N/A	DWS Length (in)	N/A	
	N/A	Landing X Slope (%)	N/A	N/A	DWS Full Width?	N/A	
	N/A	Landing Curb? (Y/N)	N/A	N/A	DWS Offset (in)	N/A	
	N/A	Shared Landing?	N/A				
	N/A	Gutter Ponding?	N/A	N/A	Gutter Slope (%)	N/A	
	N/A	Gutter Lip Ht (in)	N/A	N/A	Gutter X Slope (%)	N/A	
	N/A	Painted X Walk1?	No	N/A	Painted X Walk2?	No	
		X Walk 1 Direction	To S		X Walk 2 Direction	To E	
	N/A	X Walk 1 Width (in)	N/A	N/A	X Walk 2 Width (in)	N/A

X Walk 1 Slope (%)	1.1		X Walk 2 Slope (%)	0.1	
		X Walk 1 X Slope (%)	0.4		X Walk 2 X Slope (%)	2.7	
	N/A	Ramp inside XWalk1?	N/A	N/A	Ramp inside XWalk2?	N/A	
		Road Slope (%)	0.6	N/A	Clear Space?	N/A	
		Road X Slope (%)	1.9	N/A	Clear Space to XWalk (in)	N/A	
	N/A	Any Obstructions?	N/A	N/A	Storm Grate/Utility Hazard?	N/A	
		Obstruction Type			Storm Grate/Utility Type		
			N/A			N/A	
				Yes	Surface Condition? (G/P)	Good	
	100

Ossible Solution				
Possible Solutions:	<u>c</u>			
Remove & Replace Curb Ramp With				
Two New Directional Ramps or	Ye			
Equivalent.	N/			
	N			
	N			
	N			
Surveyor Notes:	N			
N/A	N			
	N			
	N			
	N			
PROW/ADA:	N			
Not Found, R304.5.3	N			
	N			
	N			
	N
