# Access Compliance Report

## Public Rights-of-Way

### (Curb Ramps)

| Intersection ID: 11325 | Main Street: CARROWMORE_PL | Cross Street: THORNTON_RD | Location: NW |

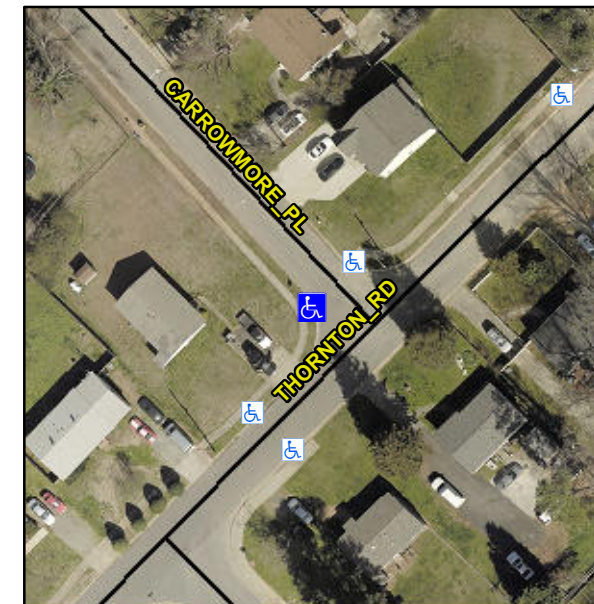
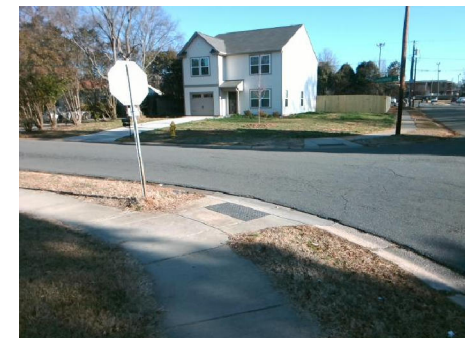
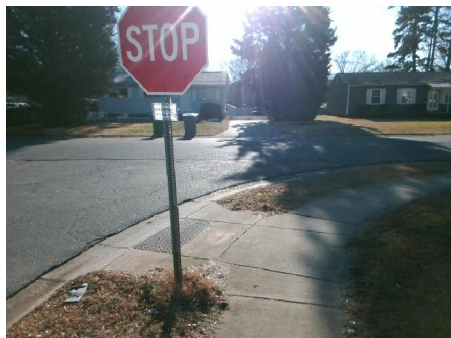
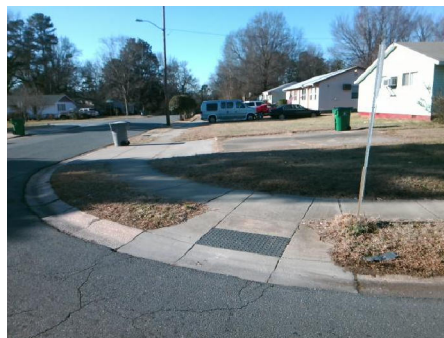
**Not Found, R304.2.2-Perp, R304.3.2-Para, R304.5.3, R302.7.2**

| Compliance | Description | Data | Compliance | Description | Data |
|---|---|---|---|---|---|
| No | Landing Slope (%) | 3.6 | Yes | DWS Length (in) | 24.0 |
| No | Landing X Slope (%) | 2.6 | Yes | DWS Full Width? | Yes |
| No | Gutter Lip Ht (in) | 1.0 | Yes | Gutter X Slope (%) | 1.2 |
| | | | No | Curb Slope (%) | 15.9 |

**Remove & Replace Curb Ramp With Two New Directional Ramps or Equivalent.**
