# Access Compliance Report

## Public Rights-of-Way

| Intersection ID: 20599 | Main Street: CARMEL_RD | Cross Street: CARMEL_PARK_LN | Location: NE |
| ADA ID: 6C7A466EEE11 | Ramp Type: PerpDiag | Initial Pass/Fail: Fail | Overall Compliance: No |

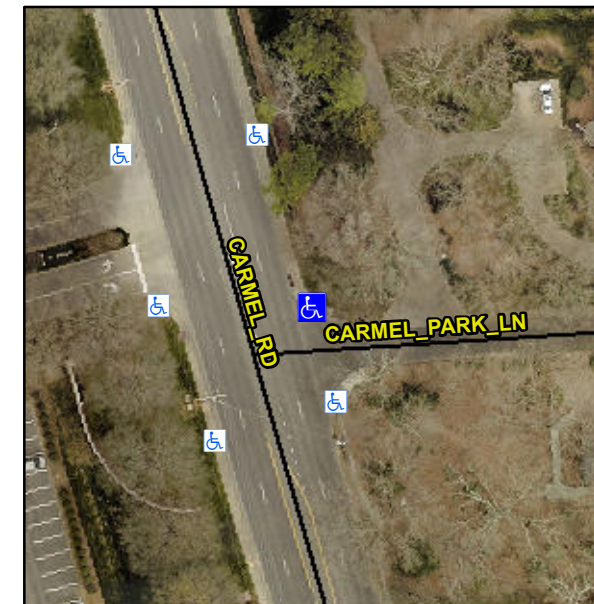
| | | Severity Score: 25 | |

**R304.2.2**

| Compliance | Description | Data | Compliance | Description | Data |
|---|---|---|---|---|---|
| N/A | Ramp Length (in) | 24.5 | No | Ramp Slope (%) | 13.1 |
| Yes | Ramp Width (in) | 48.0 | Yes | Ramp XSlope (%) | 1.0 |

Possible Solutions:

**Remove & Replace Curb Ramp With Two New Directional Ramps or Equivalent.**

Total Cost: \$ 3200.00
