## Access Compliance Report Public Rights-of-Way (Curb Ramps)

Intersection ID: 28376Main Street:GEORGIAN\_HALL\_DRCross Street:SOUTHAMPTON\_COMMONS\_DRLocation:NWADA ID: 6C7E9583A4FFRamp Type:PerpInitial Pass/Fail:FailOverall Compliance:NoSeverity Score:25

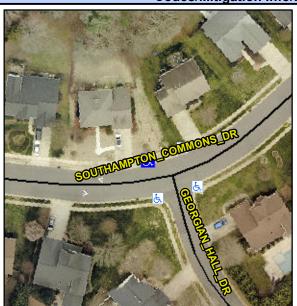
Compl	iance Description	Data	Compl	iance Description	Data
N/A	Ramp Length (in)	48.0	Yes	Ramp Slope (%)	7.2
Yes	Ramp Width (in)	48.0	No	Ramp XSlope (%)	7.1
N/A	Flare Type LT	N/A	N/A	Flare Type RT	N/A
N/A	Flare Slope LT (%)	N/A	N/A	Flare Slope RT (%)	N/A
N/A	Flare Traversable LT?	N/A	N/A	Flare Traversable RT?	N/A
N/A	Landing Length (in)	N/A	N/A	DWS Provided?	N/A
N/A	Landing Width (in)	N/A	N/A	DWS Contrast?	N/A
N/A	Landing Slope (%)	N/A	N/A	DWS Length (in)	N/A
N/A	Landing X Slope (%)	N/A	N/A	DWS Full Width?	N/A
N/A	Landing Curb? (Y/N)	N/A	N/A	DWS Offset (in)	N/A
N/A	Shared Landing?	N/A			
N/A	Gutter Ponding?	N/A	N/A	Gutter Slope (%)	N/A
N/A	Gutter Lip Ht (in)	N/A	N/A	Gutter X Slope (%)	N/A
N/A	Painted X Walk1?	No	N/A	Painted X Walk2?	N/A
	X Walk 1 Direction	To S		X Walk 2 Direction	N/A
N/A	X Walk 1 Width (in)	N/A	N/A	X Walk 2 Width (in)	N/A
	X Walk 1 Slope (%)	4.4		X Walk 2 Slope (%)	N/A
	X Walk 1 X Slope (%)	5.9		X Walk 2 X Slope (%)	N/A

N/A	Ramp inside XWalk1?	N/A	N/A	Ramp inside XWalk2?	N/A
	Road Slope (%)	N/A	N/A	Clear Space?	N/A
	Road X Slope (%)	N/A	N/A	Clear Space to XWalk (in)	N/A
N/A	Any Obstructions?	N/A	N/A	Storm Grate/Utility Hazard?	N/A
	Obstruction Type			Storm Grate/Utility Type	
		N/A			N/A
			Yes	Surface Condition? (G/P)	Good

CCCIDIC CCIGNON	
Possible Solutions:	Con
Remove & Replace Entire Ramp.	N/A
•	Yes
	N/A
	N/A
	N/A
	N/A
Surveyor Notes:	N/A
N/A	N/A
	N/A
	N/A
	N/A
PROW/ADA:	N/A
Not Found, R304.5.3	N/A
	N/A
	N/A
	N/A
