## Access Compliance Report Public Rights-of-Way (Curb Ramps)

Intersection ID: 19321
 Main Street: CHARTER\_PL
 Cross Street: KENYON\_CT
 Location:
 SW

ADA ID: 6C869FDA95BE
 Ramp Type: BlendTrans2
 Initial Pass/Fail: Fail
 Overall Compliance: No
 Severity Score:
 25

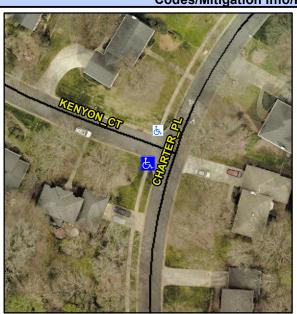
NO LNDG

Not Found, R304.5.3

| Field Measurements/Component Comphance | | | | | |
|--|---|---|---|---|---|
| Yes | Ramp Width (in) | 48.0 | No | BlendTrans XSlope (%) | 7.3 |

Remove & Replace Curb Ramp With Two New Directional Ramps or Equivalent.

Total Cost: \$ **3200.00**
