Access Compliance Report Public Rights-of-Way (Curb Ramps)

Intersection ID: 28355 Main Street: BRIDGE_CREEK_WY Cross Street: BRIDGEHAMPTON_CLUB_DR Location: SW ADA ID: 6C8E8896FF30 Ramp Type: Perp Initial Pass/Fail: Fail **Overall Compliance: No** Severity Score: 46.25

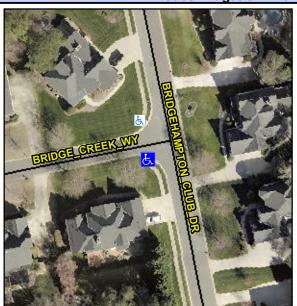
Field Measurements/Component Compliance							
Compl	liance Description	Data	Comp	liance Description	Data		
N/A	Ramp Length (in)	46.0	No	Ramp Slope (%)	8.9		
No	Ramp Width (in)	36.5	No	Ramp XSlope (%)	9.5		
N/A	Flare Type LT	N/A	N/A	Flare Type RT	N/A		
N/A	Flare Slope LT (%)	N/A	N/A	Flare Slope RT (%)	N/A		
N/A	Flare Traversable LT?	N/A	N/A	Flare Traversable RT?	N/A		
N/A	Landing Length (in)	N/A	N/A	DWS Provided?	N/A		
N/A	Landing Width (in)	N/A	N/A	DWS Contrast?	N/A		
N/A	Landing Slope (%)	N/A	N/A	DWS Length (in)	N/A		
N/A	Landing X Slope (%)	N/A	N/A	DWS Full Width?	N/A		
N/A	Landing Curb? (Y/N)	N/A	N/A	DWS Offset (in)	N/A		
N/A	Shared Landing?	N/A					
N/A	Gutter Ponding?	N/A	N/A	Gutter Slope (%)	N/A		
N/A	Gutter Lip Ht (in)	N/A	N/A	Gutter X Slope (%)	N/A		
N/A	Painted X Walk1?	No	N/A	Painted X Walk2?	N/A		
	X Walk 1 Direction	To N		X Walk 2 Direction	N/A		
N/A	X Walk 1 Width (in)	N/A	N/A	X Walk 2 Width (in)	N/A

X Walk 1 Slope (%)	7.1		X Walk 2 Slope (%)	N/A		
	X Walk 1 X Slope (%)	2.8		X Walk 2 X Slope (%)	N/A		
N/A	Ramp inside XWalk1?	N/A	N/A	Ramp inside XWalk2?	N/A		
	Road Slope (%)	N/A	N/A	Clear Space?	N/A		
	Road X Slope (%)	N/A	N/A	Clear Space to XWalk (in)	N/A		
N/A	Any Obstructions?	N/A	N/A	Storm Grate/Utility Hazard?	N/A		
	Obstruction Type			Storm Grate/Utility Type			
		N/A			N/A		
			Yes	Surface Condition? (G/P)	Good		
Ann Market

Possible Solutions:
Remove & Replace Entire Ramp.
Cumveyer Netes
Surveyor Notes:
N/A
PROW/ADA:
Not Found, R304.5.1, R304.2.2, R304.5.3
