Access Compliance Report Public Rights-of-Way (Curb Ramps)

Intersection ID: 14710	Main St	TOAT INNUMERT AN	Cross Street MCDONALD AV				Location: N	
		Main Street: LYNDHURST_AV		Cross Street: MCDONALD_AV			Location: N	
ADA ID: 6C98ED919FA9	ID: 6C98ED919FA9 Ramp Type: Perp		Initial Pass/Fail: Fail Overall Compliance			nce: N	o Severity Score:	13.75
Codes/Mitigation Info/Possible Solution			Field Measurements/Component Compliance					
		Possible Solutions:	Compliance Description Dat			a Compliance Description		Data
		Remove & Replace Entire Ramp.	N/A	Ramp Length (in)	108.0	No	Ramp Slope (%)	9.7
and M. Harris	Alex 1		Yes	Ramp Width (in)	56.0	No	Ramp XSlope (%)	4.1
	yes r		N/A	Flare Type LT	N/A	N/A	Flare Type RT	N/A
			N/A	Flare Slope LT (%)	N/A	N/A	Flare Slope RT (%)	N/A
	1		N/A	Flare Traversable LT?	N/A	N/A	Flare Traversable RT?	N/A
	and the		N/A	Landing Length (in)	N/A	N/A	DWS Provided?	N/A
A A A A A A A A A A A A A A A A A A A	1/10	Surveyor Notes:	N/A	Landing Width (in)	N/A	N/A	DWS Contrast?	N/A

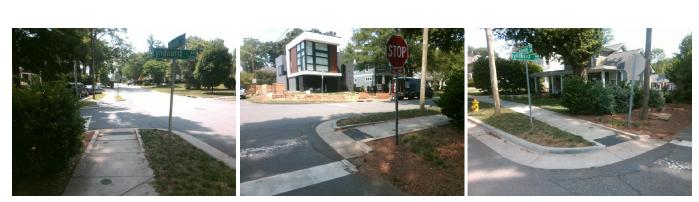
San All	N/A	N/A	Landing Slope (%)	N/A	N/A	DWS Length (in)	N/A
	Sall.		N/A	Landing X Slope (%)	N/A	N/A	DWS Full Width?	N/A
			N/A	Landing Curb? (Y/N)	N/A	N/A	DWS Offset (in)	N/A
L MAR	X		N/A	Shared Landing?	N/A			
		PROW/ADA:	N/A	Gutter Ponding?	N/A	N/A	Gutter Slope (%)	N/A
1 1 1 A Mart	1 della	R304.2.2, R304.5.3	N/A	Gutter Lip Ht (in)	N/A	N/A	Gutter X Slope (%)	N/A
		, ,	N/A	Painted X Walk1?	No	N/A	Painted X Walk2?	N/A
				X Walk 1 Direction	To SE		X Walk 2 Direction	N/A
			N/A	X Walk 1 Width (in)	N/A	N/A	X Walk 2 Width (in)	N/A
Street 1 Name LY	NDHURST AV			X Walk 1 Slope (%)	2.7		X Walk 2 Slope (%)	N/A
Stop Condition-Street 2	StopSign			X Walk 1 X Slope (%)	5.1		X Walk 2 X Slope (%)	N/A
Street 2 Name	N/A		N/A	Ramp inside XWalk1?	N/A	N/A	Ramp inside XWalk2?	N/A
Stop Condition-Street 1	N/A			Road Slope (%)	N/A	N/A	Clear Space?	N/A
				Road X Slope (%)	N/A	N/A	Clear Space to XWalk (in)	N/A
			N/A	Any Obstructions?	N/A	N/A	Storm Grate/Utility Hazard?	N/A

Total Cost: \$ 1	850.00	Obstruction Type			Storm Grate/Utility Type	
					N/A			N/A
