Access Compliance Report

Public Rights-of-Way

(Curb Ramps)

Intersection ID: 12950	Main Street: MORRIS_FIELD_DR	Cross Street: SEYMOUR_DR	Location: W
ADA ID: 6C9B919ED39A	Ramp Type: PerpDiag	Initial Pass/Fail: Fail	Overall Compliance: No
		Severity Score: 10

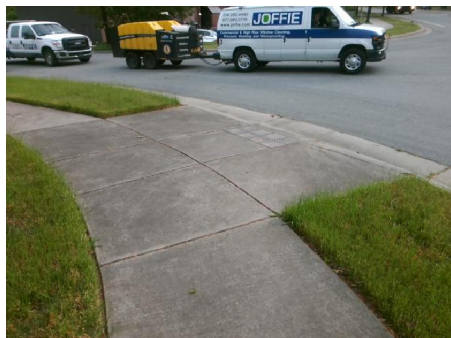
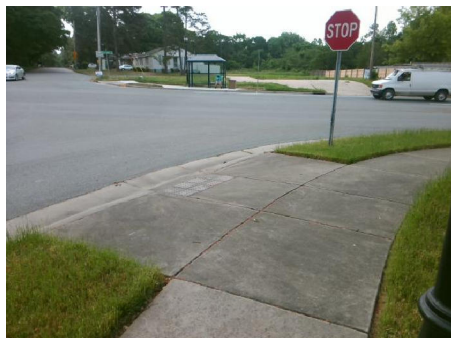
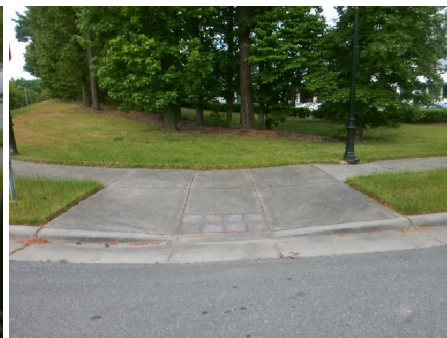
R304.5.1, R304.5.3

Compliance	Description	Data	Compliance	Description	Data
N/A	Ramp Length (in)	71.5	Yes	Ramp Slope (%)	6.8
No	Ramp Width (in)	46.0	No	Ramp XSlope (%)	3.0
N/A	Flare Type LT	N/A	N/A	Flare Type RT	N/A
N/A	Flare Slope LT (%)	N/A	N/A	Flare Slope RT (%)	N/A
N/A	Flare Traversable LT?	N/A	N/A	Flare Traversable RT?	N/A
N/A	Landing Length (in)	N/A	N/A	DWS Provided?	N/A
N/A	Landing Width (in)	N/A	N/A	DWS Contrast?	N/A
N/A	Landing Slope (%)	N/A	N/A	DWS Length (in)	N/A
N/A	Landing X Slope (%)	N/A	N/A	DWS Full Width?	N/A
N/A	Landing Curb? (Y/N)	N/A	N/A	DWS Offset (in)	N/A
N/A	Shared Landing?	N/A			
N/A	Gutter Ponding?	N/A	N/A	Gutter Slope (%)	N/A
N/A	Gutter Lip Ht (in)	N/A	N/A	Gutter X Slope (%)	N/A
N/A	Painted X Walk1?	No	N/A	Painted X Walk2?	No
	X Walk 1 Direction	To SE		X Walk 2 Direction	To NE
N/A	X Walk 1 Width (in)	N/A	N/A	X Walk 2 Width (in)	N/A
	X Walk 1 Slope (%)	1.4		X Walk 2 Slope (%)	3.1
	X Walk 1 X Slope (%)	0.4		X Walk 2 X Slope (%)	0.2

N/A	Ramp inside XWalk1?	N/A	N/A	Ramp inside XWalk2?	N/A
	Road Slope (%)	0.9	N/A	Clear Space?	N/A
	Road X Slope (%)	1.4	N/A	Clear Space to XWalk (in)	N/A
N/A	Any Obstructions?	N/A	N/A	Storm Grate/Utility Hazard?	N/A
	Obstruction Type			Storm Grate/Utility Type	
		N/A			N/A
			Yes	Surface Condition? (G/P)	Good

Remove & Replace Curb Ramp With Two New Directional Ramps or Equivalent.
