Access Compliance Report

Public Rights-of-Way

(Curb Ramps)

Intersection ID: 50633	Main Street: BLUE_BLOSSOM_RD	Cross Street: CORAL_ROSE_RD	Location: E
ADA ID: 6C9D979751EB	Ramp Type: Perp	Initial Pass/Fail: Fail	Overall Compliance: No
Severity Score: 12.5			
Codes/Mitigation Info/Possible Solution		Field Measurements/Component Compliance

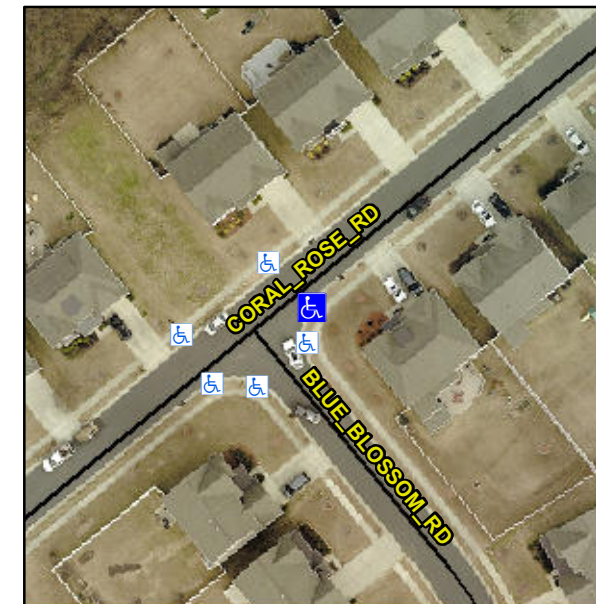
Not Found, R304.2.2

Compliance	Description	Data	Compliance	Description	Data
N/A	Ramp Length (in)	44.0	No	Ramp Slope (%)	8.5
Yes	Ramp Width (in)	48.0	Yes	Ramp XSlope (%)	1.3
N/A	Flare Type LT	N/A	N/A	Flare Type RT	N/A
N/A	Flare Slope LT (%)	N/A	N/A	Flare Slope RT (%)	N/A
N/A	Flare Traversable LT?	N/A	N/A	Flare Traversable RT?	N/A
N/A	Landing Length (in)	N/A	N/A	DWS Provided?	N/A
N/A	Landing Width (in)	N/A	N/A	DWS Contrast?	N/A
N/A	Landing Slope (%)	N/A	N/A	DWS Length (in)	N/A
N/A	Landing X Slope (%)	N/A	N/A	DWS Full Width?	N/A
N/A	Landing Curb? (Y/N)	N/A	N/A	DWS Offset (in)	N/A
N/A	Shared Landing?	N/A			
N/A	Gutter Ponding?	N/A	N/A	Gutter Slope (%)	N/A
N/A	Gutter Lip Ht (in)	N/A	N/A	Gutter X Slope (%)	N/A
N/A	Painted X Walk1?	No	N/A	Painted X Walk2?	N/A
	X Walk 1 Direction	To NW		X Walk 2 Direction	N/A
N/A	X Walk 1 Width (in)	N/A	N/A	X Walk 2 Width (in)	N/A
	X Walk 1 Slope (%)	2.6		X Walk 2 Slope (%)	N/A
	X Walk 1 X Slope (%)	0.7		X Walk 2 X Slope (%)	N/A

N/A	Ramp inside XWalk1?	N/A	N/A	Ramp inside XWalk2?	N/A
	Road Slope (%)	N/A	N/A	Clear Space?	N/A
	Road X Slope (%)	N/A	N/A	Clear Space to XWalk (in)	N/A
N/A	Any Obstructions?	N/A	N/A	Storm Grate/Utility Hazard?	N/A
	Obstruction Type			Storm Grate/Utility Type	
		N/A			N/A
			Yes	Surface Condition? (G/P)	Good

Possible Solutions:

Remove & Replace Entire Ramp.
