Access Compliance Report

Public Rights-of-Way

(Curb Ramps)

Intersection ID: 48369	Main Street: WHEATFIELD_RD	Cross Street: TURKEY_HILL_RD	Location: SE
ADA ID: 6CB0A95DE05D	Ramp Type: PerpDiag	Initial Pass/Fail: Pass	Overall Compliance: No
Severity Score: 5			
Codes/Mitigation Info/Possible Solution		Field Measurements/Component Compliance

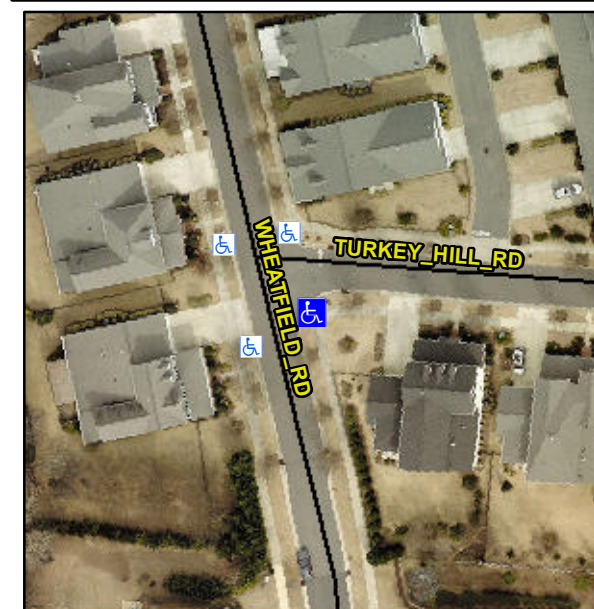
Not Found, R305.2, R304.5.4

Compliance	Description	Data	Compliance	Description	Data
N/A	Ramp Length (in)	72.0	Yes	Ramp Slope (%)	7.3
Yes	Ramp Width (in)	48.0	Yes	Ramp XSlope (%)	0.9
N/A	Flare Type LT	Sloped	N/A	Flare Type RT	N/A
N/A	Flare Slope LT (%)	7.0	Yes	Flare Slope RT (%)	3.7
N/A	Flare Traversable LT?	Yes	N/A	Flare Traversable RT?	Yes
Yes	Landing Length (in)	59.0	Yes	DWS Provided?	Yes
Yes	Landing Width (in)	48.0	Yes	DWS Contrast?	Yes
Yes	Landing Slope (%)	1.9	Yes	DWS Length (in)	24.0
Yes	Landing X Slope (%)	0.1	Yes	DWS Full Width?	Yes
N/A	Landing Curb? (Y/N)	No	No	DWS Offset (in)	6.0
N/A	Shared Landing?	No			
Yes	Gutter Ponding?	No	No	Gutter Slope (%)	7.8
Yes	Gutter Lip Ht (in)	0.0	Yes	Gutter X Slope (%)	1.3
N/A	Painted X Walk1?	No	N/A	Painted X Walk2?	No
	X Walk 1 Direction	To W		X Walk 2 Direction	To N
N/A	X Walk 1 Width (in)	N/A	N/A	X Walk 2 Width (in)	N/A
	X Walk 1 Slope (%)	1.0		X Walk 2 Slope (%)	0.5
	X Walk 1 X Slope (%)	0.1		X Walk 2 X Slope (%)	0.4

N/A	Ramp inside XWalk1?	N/A	N/A	Ramp inside XWalk2?	N/A
	Road Slope (%)	0.5	N/A	Clear Space?	Yes
	Road X Slope (%)	1.8	N/A	Clear Space to XWalk (in)	N/A
Yes	Any Obstructions?	No	Yes	Storm Grate/Utility Hazard?	No
	Obstruction Type			Storm Grate/Utility Type	
		N/A			N/A
			Yes	Surface Condition? (G/P)	Good

Possible Solutions:

Remove & Replace Curb Ramp With Two New Directional Ramps or Equivalent. Remove & Replace Gutter.
