# Access Compliance Report

## Public Rights-of-Way

### (Curb Ramps)

Intersection ID: 18423	Main Street: ELESSAR_PL	Cross Street: STRIDER_DR	Location: SW
ADA ID: 6CC54245775C	Ramp Type: PerpDiag	Initial Pass/Fail: Fail	Overall Compliance: No
Codes/Mitigation Info/Possible Solution			Severity Score: 30
			Field Measurements/Component Compliance

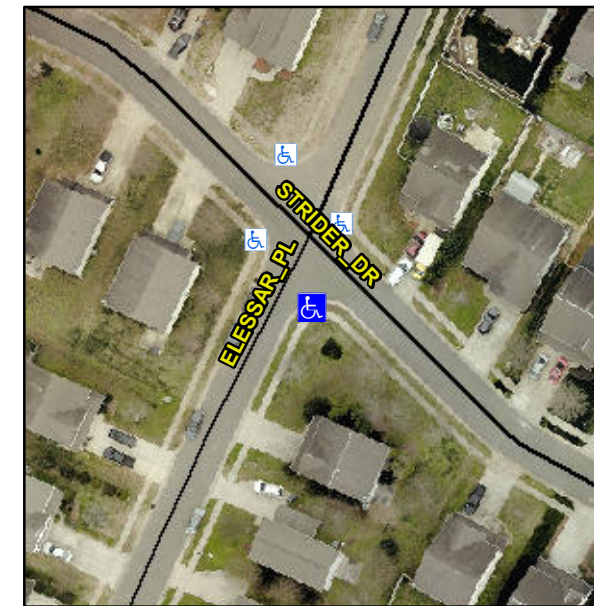
Compliance	Description	Data	Compliance	Description	Data
N/A	Ramp Length (in)	48.0	Yes	Ramp Slope (%)	6.4
No	Ramp Width (in)	35.0	No	Ramp XSlope (%)	6.7
N/A	Flare Type LT	N/A	N/A	Flare Type RT	N/A
N/A	Flare Slope LT (%)	N/A	N/A	Flare Slope RT (%)	N/A
N/A	Flare Traversable LT?	N/A	N/A	Flare Traversable RT?	N/A
N/A	Landing Length (in)	N/A	N/A	DWS Provided?	N/A
N/A	Landing Width (in)	N/A	N/A	DWS Contrast?	N/A
N/A	Landing Slope (%)	N/A	N/A	DWS Length (in)	N/A
N/A	Landing X Slope (%)	N/A	N/A	DWS Full Width?	N/A
N/A	Landing Curb? (Y/N)	N/A	N/A	DWS Offset (in)	N/A
N/A	Shared Landing?	N/A			
N/A	Gutter Ponding?	N/A	N/A	Gutter Slope (%)	N/A
N/A	Gutter Lip Ht (in)	N/A	N/A	Gutter X Slope (%)	N/A
N/A	Painted X Walk1?	No	N/A	Painted X Walk2?	No
	X Walk 1 Direction	To NE		X Walk 2 Direction	To NW
N/A	X Walk 1 Width (in)	N/A	N/A	X Walk 2 Width (in)	N/A
	X Walk 1 Slope (%)	2.1		X Walk 2 Slope (%)	4.9
	X Walk 1 X Slope (%)	3.2		X Walk 2 X Slope (%)	5.3

N/A	Ramp inside XWalk1?	N/A	N/A	Ramp inside XWalk2?	N/A
	Road Slope (%)	6.5	N/A	Clear Space?	N/A
	Road X Slope (%)	3.6	N/A	Clear Space to XWalk (in)	N/A
N/A	Any Obstructions?	N/A	N/A	Storm Grate/Utility Hazard?	N/A
	Obstruction Type			Storm Grate/Utility Type	
		N/A			N/A
			Yes	Surface Condition? (G/P)	Good

Possible Solutions:

**Remove & Replace Curb Ramp With Two New Directional Ramps or Equivalent.**

**R304.5.1, R304.5.3**
