Access Compliance Report

Public Rights-of-Way (Curb Ramps)

Intersection ID: 15545	Main Street: ELMHURST_RD	Cross Street: POINDEXTER_DR	Location:	N
ADA ID: 6CD0F4EB7A30	Ramp Type: Perp	Initial Pass/Fail: Fail	Overall Compliance: No	Severity Score: 25
Codes/Mitigation Info/Possible Solution		Field Measurements/Component Compliance

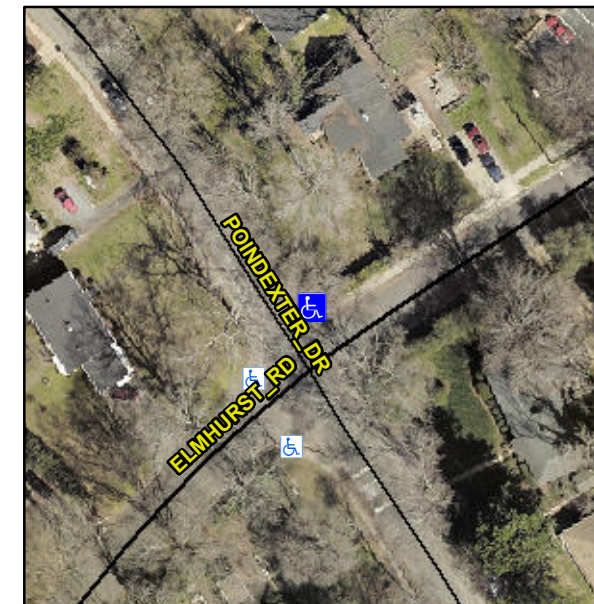
Compliance	Description	Data	Compliance	Description	Data
N/A	Ramp Length (in)	72.0	No	Ramp Slope (%)	12.2
Yes	Ramp Width (in)	48.0	Yes	Ramp XSlope (%)	1.3
N/A	Flare Type LT	N/A	N/A	Flare Type RT	N/A
N/A	Flare Slope LT (%)	N/A	N/A	Flare Slope RT (%)	N/A
N/A	Flare Traversable LT?	N/A	N/A	Flare Traversable RT?	N/A
N/A	Landing Length (in)	N/A	N/A	DWS Provided?	N/A
N/A	Landing Width (in)	N/A	N/A	DWS Contrast?	N/A
N/A	Landing Slope (%)	N/A	N/A	DWS Length (in)	N/A
N/A	Landing X Slope (%)	N/A	N/A	DWS Full Width?	N/A
N/A	Landing Curb? (Y/N)	N/A	N/A	DWS Offset (in)	N/A
N/A	Shared Landing?	N/A			
N/A	Gutter Ponding?	N/A	N/A	Gutter Slope (%)	N/A
N/A	Gutter Lip Ht (in)	1.0	N/A	Gutter X Slope (%)	N/A
N/A	Painted X Walk1?	No	N/A	Painted X Walk2?	N/A
	X Walk 1 Direction	To SW		X Walk 2 Direction	N/A
N/A	X Walk 1 Width (in)	N/A	N/A	X Walk 2 Width (in)	N/A
	X Walk 1 Slope (%)	4.5		X Walk 2 Slope (%)	N/A
	X Walk 1 X Slope (%)	2.4		X Walk 2 X Slope (%)	N/A

Possible Solutions:

Remove & Replace Entire Ramp.
