Access Compliance Report

Public Rights-of-Way

(Curb Ramps)

Intersection ID: N/A	Main Street: ST_JOHNS_CHURCH_RD	Cross Street: W_T_HARRIS_BV	Location: E
ADA ID: 6CD7D78BD1B0	Ramp Type: Directional1	Initial Pass/Fail: Fail	Overall Compliance: No
Severity Score: 1.25			
Codes/Mitigation Info/Possible Solution		Field Measurements/Component Compliance

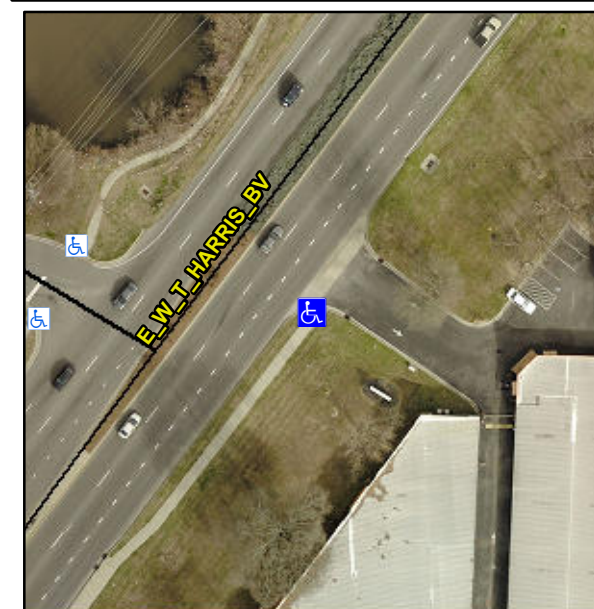
Compliance	Description	Data	Compliance	Description	Data
N/A	Ramp Length (in)	121.0	N/A	Grade Break?	N/A
Yes	Ramp Width (in)	72.0	N/A	Grade Break Slope (%)	0.0
Yes	Ramp Slope (%)	2.5	N/A	Grade Break XSlope (%)	0.0
No	Ramp XSlope (%)	2.2			
N/A	Flare Type LT	N/A	N/A	Flare Type RT	N/A
N/A	Flare Slope LT (%)	N/A	N/A	Flare Slope RT (%)	0.0
N/A	Flare Traversable LT?	N/A	N/A	Flare Traversable RT?	N/A
N/A	Landing Length (in)	0.0	N/A	DWS Provided?	N/A
N/A	Landing Width (in)	0.0	N/A	DWS Contrast?	N/A
N/A	Landing Slope (%)	0.0	N/A	DWS Length (in)	N/A
N/A	Landing X Slope (%)	0.0	N/A	DWS Full Width?	N/A
N/A	Landing Curb? (Y/N)	N/A	N/A	DWS Offset LT (in)	N/A
N/A	Shared Landing?	N/A	N/A	DWS Offset RT (in)	N/A
N/A	Gutter Ponding?	0.0	N/A	Gutter Slope (%)	N/A
N/A	Gutter Lip Ht (in)	0.0	N/A	Gutter X Slope (%)	N/A
N/A	Painted X Walk1?	No		Road Slope (%)	0.4
	X Walk 1 Direction	To NE		Road X Slope (%)	4.6
	X Walk 1 Width (in)	N/A		Clear Space?	N/A

X Walk 1 Slope (%)	0.4	N/A	Clear Space to XWalk (in)	N/A
	X Walk 1 X Slope (%)	4.6	N/A	Storm Grate/Utility Hazard?	N/A
N/A	Ramp inside XWalk1?	N/A		Storm Grate/Utility Type	
N/A	Any Obstructions?	N/A			N/A
	Obstruction Type		Yes	Surface Condition? (G/P)	Good
			N/A	Curb Slope (%)	2.8

Possible Solutions:

Remove & Replace Entire Ramp.
