Access Compliance Report

Public Rights-of-Way

(Curb Ramps)

Intersection ID: 20143	Main Street: CANNARTI_DR	Cross Street: CEDAR_HILL_DR	Location: NE
ADA ID: 6CDF41B9CBE0	Ramp Type: PerpDiag	Initial Pass/Fail: Fail	Overall Compliance: No
		Severity Score: 12.5

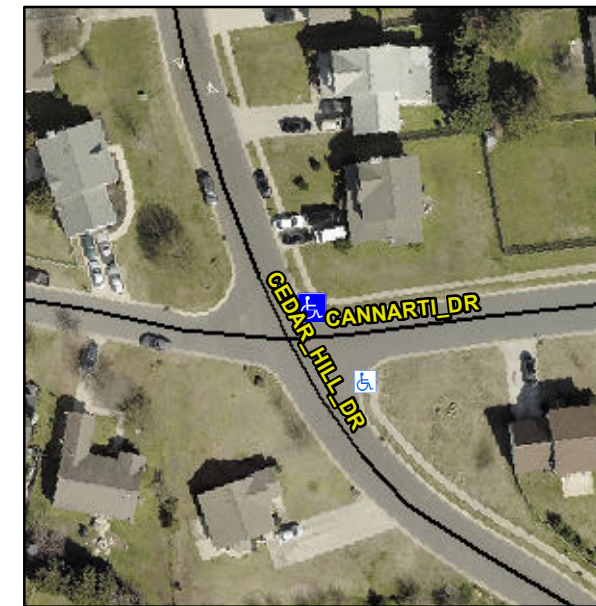
Compliance	Description	Data	Compliance	Description	Data
N/A	Ramp Length (in)	49.0	Yes	Ramp Slope (%)	7.0
Yes	Ramp Width (in)	48.0	No	Ramp XSlope (%)	6.0
N/A	Flare Type LT	N/A	N/A	Flare Type RT	N/A
N/A	Flare Slope LT (%)	N/A	N/A	Flare Slope RT (%)	N/A
N/A	Flare Traversable LT?	N/A	N/A	Flare Traversable RT?	N/A
N/A	Landing Length (in)	N/A	N/A	DWS Provided?	N/A
N/A	Landing Width (in)	N/A	N/A	DWS Contrast?	N/A
N/A	Landing Slope (%)	N/A	N/A	DWS Length (in)	N/A
N/A	Landing X Slope (%)	N/A	N/A	DWS Full Width?	N/A
N/A	Landing Curb? (Y/N)	N/A	N/A	DWS Offset (in)	N/A
N/A	Shared Landing?	N/A			
N/A	Gutter Ponding?	N/A	N/A	Gutter Slope (%)	N/A
N/A	Gutter Lip Ht (in)	N/A	N/A	Gutter X Slope (%)	N/A
N/A	Painted X Walk1?	No	N/A	Painted X Walk2?	No
	X Walk 1 Direction	To NW		X Walk 2 Direction	To SE
N/A	X Walk 1 Width (in)	N/A	N/A	X Walk 2 Width (in)	N/A
	X Walk 1 Slope (%)	2.4		X Walk 2 Slope (%)	0.8
	X Walk 1 X Slope (%)	2.1		X Walk 2 X Slope (%)	0.3

N/A	Ramp inside XWalk1?	N/A	N/A	Ramp inside XWalk2?	N/A
	Road Slope (%)	2.2	N/A	Clear Space?	N/A
	Road X Slope (%)	2.5	N/A	Clear Space to XWalk (in)	N/A
N/A	Any Obstructions?	N/A	N/A	Storm Grate/Utility Hazard?	N/A
	Obstruction Type			Storm Grate/Utility Type	
		N/A			N/A
		Yes		Surface Condition? (G/P)	Good

Remove & Replace Curb Ramp With Two New Directional Ramps or Equivalent.

R304.5.3
