# Access Compliance Report

## Public Rights-of-Way

### (Curb Ramps)

Intersection ID: 15153	Main Street: GRIFFITH_ST	Cross Street: POINDEXTER_DR	Location: SE
ADA ID: 6CE32C099892	Ramp Type: Perp	Initial Pass/Fail: Fail	Overall Compliance: No
Severity Score: 12.5			
Codes/Mitigation Info/Possible Solution		Field Measurements/Component Compliance

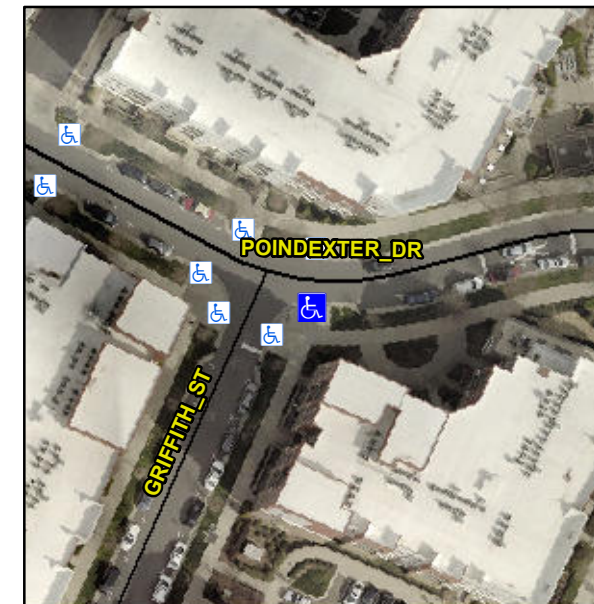
**Not Found, R304.5.3**

Compliance	Description	Data	Compliance	Description	Data
N/A	Ramp Length (in)	141.0	Yes	Ramp Slope (%)	5.5
Yes	Ramp Width (in)	48.0	No	Ramp XSlope (%)	5.2
N/A	Flare Type LT	N/A	N/A	Flare Type RT	N/A
N/A	Flare Slope LT (%)	N/A	N/A	Flare Slope RT (%)	N/A
N/A	Flare Traversable LT?	N/A	N/A	Flare Traversable RT?	N/A
N/A	Landing Length (in)	N/A	N/A	DWS Provided?	N/A
N/A	Landing Width (in)	N/A	N/A	DWS Contrast?	N/A
N/A	Landing Slope (%)	N/A	N/A	DWS Length (in)	N/A
N/A	Landing X Slope (%)	N/A	N/A	DWS Full Width?	N/A
N/A	Landing Curb? (Y/N)	N/A	N/A	DWS Offset (in)	N/A
N/A	Shared Landing?	N/A			
N/A	Gutter Ponding?	N/A	N/A	Gutter Slope (%)	N/A
N/A	Gutter Lip Ht (in)	N/A	N/A	Gutter X Slope (%)	N/A
N/A	Painted X Walk1?	No	N/A	Painted X Walk2?	N/A
	X Walk 1 Direction	To N		X Walk 2 Direction	N/A
N/A	X Walk 1 Width (in)	N/A	N/A	X Walk 2 Width (in)	N/A
	X Walk 1 Slope (%)	2.2		X Walk 2 Slope (%)	N/A
	X Walk 1 X Slope (%)	1.9		X Walk 2 X Slope (%)	N/A

**Remove & Replace Entire Ramp.**
