Access Compliance Report

Public Rights-of-Way

(Curb Ramps)

Intersection ID: 14681	Main Street: FAIRWOOD_AV	Cross Street: GRIFFITH_ST	Location:	E
ADA ID: 6CE8F68EBB92	Ramp Type: Perp	Initial Pass/Fail: Fail	Overall Compliance: No	Severity Score: 22.5
Codes/Mitigation Info/Possible Solution		Field Measurements/Component Compliance

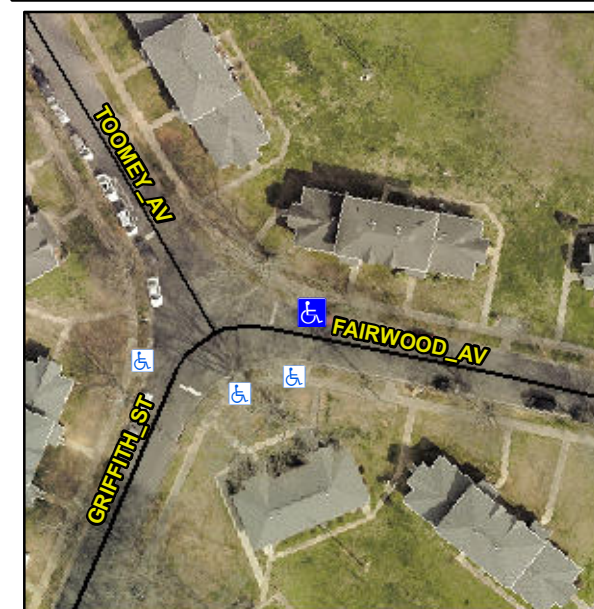
R304.5.1, R304.2.2, R304.5.3

Compliance	Description	Data	Compliance	Description	Data
N/A	Ramp Length (in)	61.5	No	Ramp Slope (%)	10.5
No	Ramp Width (in)	46.0	No	Ramp XSlope (%)	2.4
N/A	Flare Type LT	N/A	N/A	Flare Type RT	N/A
N/A	Flare Slope LT (%)	N/A	N/A	Flare Slope RT (%)	N/A
N/A	Flare Traversable LT?	N/A	N/A	Flare Traversable RT?	N/A
N/A	Landing Length (in)	N/A	N/A	DWS Provided?	N/A
N/A	Landing Width (in)	N/A	N/A	DWS Contrast?	N/A
N/A	Landing Slope (%)	N/A	N/A	DWS Length (in)	N/A
N/A	Landing X Slope (%)	N/A	N/A	DWS Full Width?	N/A
N/A	Landing Curb? (Y/N)	N/A	N/A	DWS Offset (in)	N/A
N/A	Shared Landing?	N/A			
N/A	Gutter Ponding?	N/A	N/A	Gutter Slope (%)	N/A
N/A	Gutter Lip Ht (in)	N/A	N/A	Gutter X Slope (%)	N/A
N/A	Painted X Walk1?	No	N/A	Painted X Walk2?	N/A
	X Walk 1 Direction	To SW		X Walk 2 Direction	N/A
N/A	X Walk 1 Width (in)	N/A	N/A	X Walk 2 Width (in)	N/A
	X Walk 1 Slope (%)	3.1		X Walk 2 Slope (%)	N/A
	X Walk 1 X Slope (%)	2.2		X Walk 2 X Slope (%)	N/A

Remove & Replace Entire Ramp.
