Access Compliance Report Public Rights-of-Way (Curb Ramps)

Intersection ID: 31304 Main Street: WESTBEND DR **Cross Street: ALEXANDER POINTE DR** Location: SE ADA ID: 6CEB8525F78E Ramp Type: PerpDiag Initial Pass/Fail: Fail **Overall Compliance: No Severity Score:** 22.5

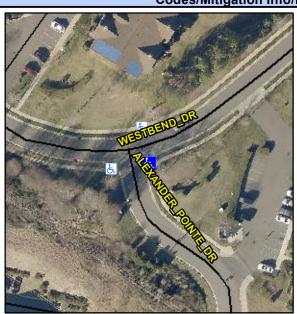
Field Measurements/Component Compliance						
Comp	Compliance Description		Comp	liance Description	Data	
N/A	Ramp Length (in)	49.0	No	Ramp Slope (%)	8.9	
No	Ramp Width (in)	36.0	No	Ramp XSlope (%)	5.0	
N/A	Flare Type LT	N/A	N/A	Flare Type RT	N/A	
N/A	Flare Slope LT (%)	N/A	N/A	Flare Slope RT (%)	N/A	
N/A	Flare Traversable LT?	N/A	N/A	Flare Traversable RT?	N/A	
N/A	Landing Length (in)	N/A	N/A	DWS Provided?	N/A	
N/A	Landing Width (in)	N/A	N/A	DWS Contrast?	N/A	
N/A	Landing Slope (%)	N/A	N/A	DWS Length (in)	N/A	
N/A	Landing X Slope (%)	N/A	N/A	DWS Full Width?	N/A	
N/A	Landing Curb? (Y/N)	N/A	N/A	DWS Offset (in)	N/A	
N/A	Shared Landing?	N/A				
N/A	Gutter Ponding?	N/A	N/A	Gutter Slope (%)	N/A	
N/A	Gutter Lip Ht (in)	N/A	N/A	Gutter X Slope (%)	N/A	
N/A	Painted X Walk1?	No	N/A	Painted X Walk2?	No	
	X Walk 1 Direction	To N		X Walk 2 Direction	To W	
N/A	X Walk 1 Width (in)	N/A	N/A	X Walk 2 Width (in)	N/A	
	X Walk 1 Slope (%)	5.5		X Walk 2 Slope (%)	8.4

X Walk 1 X Slope (%)	5.7		X Walk 2 X Slope (%)	2.9	
N/A	Ramp inside XWalk1?	N/A	N/A	Ramp inside XWalk2?	N/A	
	Road Slope (%)	1.9	N/A	Clear Space?	N/A	
	Road X Slope (%)	7.5	N/A	Clear Space to XWalk (in)	N/A	
N/A	Any Obstructions?	N/A	N/A	Storm Grate/Utility Hazard?	N/A	
	Obstruction Type			Storm Grate/Utility Type		
		N/A			N/A	
			Yes	Surface Condition? (G/P)	Good	
DESCRIPTION OF THE PERSON OF T	11 10

Possible Solutions: Remove & Replace Curb Ramp With **Two New Directional Ramps or** Equivalent. Survey N/A PROW **R30**

N/A
	N/A
eyor Notes:	N/A
\	N/A
	N/A
	N/A
	N/A
W/ADA:	N/A
304.5.1, R304.2.2, R304.5.3	N/A
	N/A
	N/A
	N/A
	N/A
Cost: \$	3200.00
