Surface Condition? (G/P)

Intersection ID: 9497 Main Street: BENARD\_AV Cross Street: E\_36TH\_ST Location: W

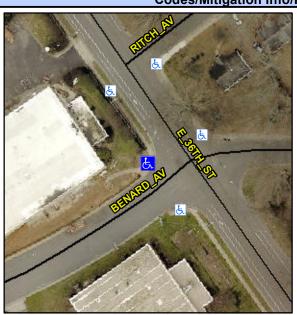
PROW/ADA:

Total Cost: \$ 3200.00

Compliance Description		Data	Compliance Description		Data
N	A Ramp Length (in)	60.0	Yes	Ramp Slope (%)	5.7
N	o Ramp Width (in)	39.5	No	Ramp XSlope (%)	8.3
N	A Flare Type LT	N/A	N/A	Flare Type RT	N/A
N	/A Flare Slope LT (%)	N/A	N/A	Flare Slope RT (%)	N/A
N	/A Flare Traversable LT?	N/A	N/A	Flare Traversable RT?	N/A
N	/A Landing Length (in)	N/A	N/A	DWS Provided?	N/A
N	/A Landing Width (in)	N/A	N/A	DWS Contrast?	N/A
N	/A Landing Slope (%)	N/A	N/A	DWS Length (in)	N/A
N	/A Landing X Slope (%)	N/A	N/A	DWS Full Width?	N/A
N	/A Landing Curb? (Y/N)	N/A	N/A	DWS Offset (in)	N/A
N	A Shared Landing?	N/A			
N	A Gutter Ponding?	N/A	N/A	Gutter Slope (%)	N/A
N	A Gutter Lip Ht (in)	1.0	N/A	Gutter X Slope (%)	N/A
N	/A Painted X Walk1?	No	N/A	Painted X Walk2?	No
	X Walk 1 Direction	To SE		X Walk 2 Direction	To NE
N	/A X Walk 1 Width (in)	N/A	N/A	X Walk 2 Width (in)	N/A
	X Walk 1 Slope (%)	0.9		X Walk 2 Slope (%)	4.2
	X Walk 1 X Slope (%)	1.7		X Walk 2 X Slope (%)	3.7

Possible Solutions:
