Access Compliance Report

Public Rights-of-Way

(Curb Ramps)

Intersection ID: 12971	Main Street: HERONWOOD_LN	Cross Street: PENCE_POND_LN	Location: S
ADA ID: 6D068C6BEE97	Ramp Type: Perp	Initial Pass/Fail: Fail	Overall Compliance: No
Severity Score: 8.75			
Codes/Mitigation Info/Possible Solution		Field Measurements/Component Compliance

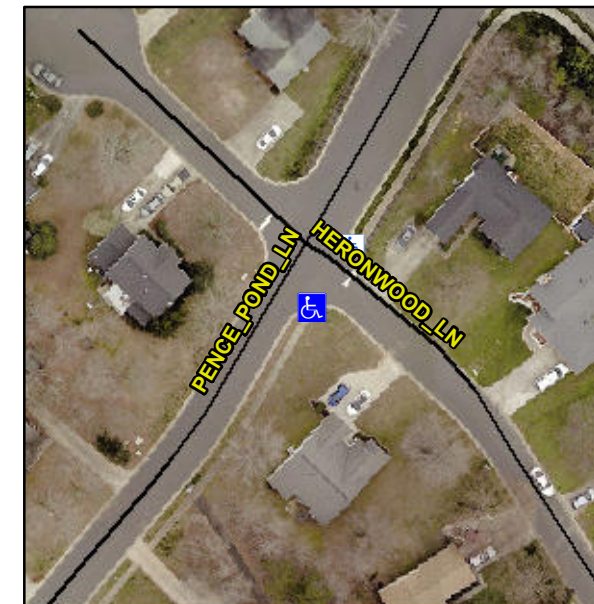
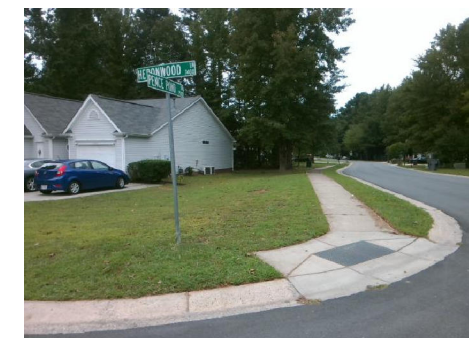
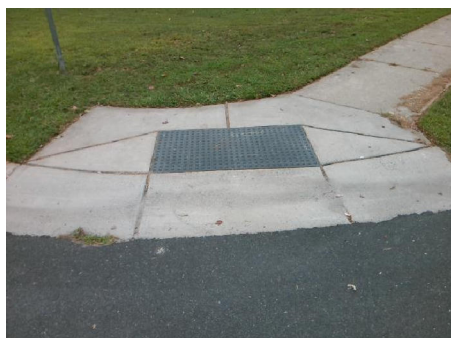
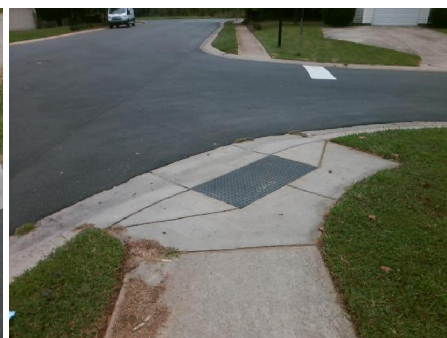
Not Found, R304.5.1

Compliance	Description	Data	Compliance	Description	Data
N/A	Ramp Length (in)	44.0	Yes	Ramp Slope (%)	7.7
No	Ramp Width (in)	47.5	Yes	Ramp XSlope (%)	0.8
N/A	Flare Type LT	N/A	N/A	Flare Type RT	N/A
N/A	Flare Slope LT (%)	N/A	N/A	Flare Slope RT (%)	N/A
N/A	Flare Traversable LT?	N/A	N/A	Flare Traversable RT?	N/A
N/A	Landing Length (in)	N/A	N/A	DWS Provided?	N/A
N/A	Landing Width (in)	N/A	N/A	DWS Contrast?	N/A
N/A	Landing Slope (%)	N/A	N/A	DWS Length (in)	N/A
N/A	Landing X Slope (%)	N/A	N/A	DWS Full Width?	N/A
N/A	Landing Curb? (Y/N)	N/A	N/A	DWS Offset (in)	N/A
N/A	Shared Landing?	N/A			
N/A	Gutter Ponding?	N/A	N/A	Gutter Slope (%)	N/A
N/A	Gutter Lip Ht (in)	N/A	N/A	Gutter X Slope (%)	N/A
N/A	Painted X Walk1?	No	N/A	Painted X Walk2?	N/A
	X Walk 1 Direction	To NE		X Walk 2 Direction	N/A
N/A	X Walk 1 Width (in)	N/A	N/A	X Walk 2 Width (in)	N/A
	X Walk 1 Slope (%)	1.1		X Walk 2 Slope (%)	N/A
	X Walk 1 X Slope (%)	3.6		X Walk 2 X Slope (%)	N/A

N/A	Ramp inside XWalk1?	N/A	N/A	Ramp inside XWalk2?	N/A
	Road Slope (%)	N/A	N/A	Clear Space?	N/A
	Road X Slope (%)	N/A	N/A	Clear Space to XWalk (in)	N/A
N/A	Any Obstructions?	N/A	N/A	Storm Grate/Utility Hazard?	N/A
	Obstruction Type			Storm Grate/Utility Type	
		N/A			N/A
			Yes	Surface Condition? (G/P)	Good

Remove & Replace Entire Ramp.

Total Cost: \$ 1850.00
