Access Compliance Report Public Rights-of-Way (Curb Ramps)

Intersection ID: 42040	Main Ctu		0	C4		D		Leastien	05
Intersection ID: 43646	on ID: 43646 Main Street: CEDAR_CROSSINGS_DR		Cross	Cross Street: CALLOW_FOREST_DR				Location:	SE
ADA ID: 6D1C63AD60	D: 6D1C63AD609C Ramp Type: PerpDiag		Initial I	nitial Pass/Fail: Fail Overall Compliance: N				Severity Score:	13.75
Codes/Mitigation Info/Possible Solution				Field Measurements/Component Compliance					
The second se		Possible Solutions:		Comp	liance Description	ce Description Data		Compliance Description

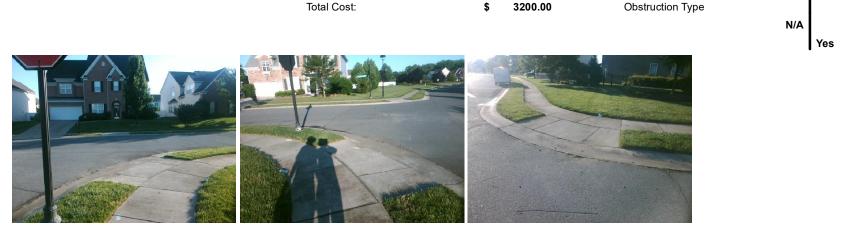
- Thomas I		Remove & Replace Curb Ramp V	Vith	N/A	Ramp Length (in)	48.0	No	Ramp Slope (%)	9.7
		Two New Directional Ramps or Equivalent.		Yes	Ramp Width (in)	57.0	No	Ramp XSlope (%)	3.1
				N/A	Flare Type LT	N/A	N/A	Flare Type RT	N/A
a the second of the				N/A	Flare Slope LT (%)	N/A	N/A	Flare Slope RT (%)	N/A

*			N/A	Flare Traversable LT?	N/A	N/A	Flare Traversable RT?	N/A
GEDAR OR	OSSINGS_DR			N/A	Landing Length (in)	N/A	N/A	DWS Provided?	N/A
Statement of the second se		Surveyor Notes:		N/A	Landing Width (in)	N/A	N/A	DWS Contrast?	N/A
	the second second	N/A		N/A	Landing Slope (%)	N/A	N/A	DWS Length (in)	N/A
PROW/ADA: R304.2.2, R304.5.3				N/A	Landing X Slope (%)	N/A	N/A	DWS Full Width?	N/A
				N/A	Landing Curb? (Y/N)	N/A	N/A	DWS Offset (in)	N/A
				N/A	Shared Landing?	N/A			
				N/A	Gutter Ponding?	N/A	N/A	Gutter Slope (%)	N/A
				N/A	Gutter Lip Ht (in)	N/A	N/A	Gutter X Slope (%)	N/A
				N/A	Painted X Walk1?	No	N/A	Painted X Walk2?	No
A THE THE					X Walk 1 Direction	To N		X Walk 2 Direction	To W
				N/A	X Walk 1 Width (in)	N/A	N/A	X Walk 2 Width (in)	N/A
Street 1 Name	CEDAR CROSSINGS DR				X Walk 1 Slope (%)	0.6		X Walk 2 Slope (%)	0.6
Stop Condition-Street 2	None				X Walk 1 X Slope (%)	1.9		X Walk 2 X Slope (%)	1.6

Street 2 Name	CALLOW FOREST DR			N/A	Ramp inside XWalk1?	N/A	N/A	Ramp inside XWalk2?	N/A
Stop Condition-Street 1	StopSign				Road Slope (%)	0.1	N/A	Clear Space?	N/A
					Road X Slope (%)	4.5	N/A	Clear Space to XWalk (in)	N/A
				N/A	Any Obstructions?	N/A	N/A	Storm Grate/Utility Hazard?	N/A
		Total Cost: \$ 3	200.00		Obstruction Type			Storm Grate/Utility Type	
						N/A			N/A
