Access Compliance Report

Public Rights-of-Way

(Curb Ramps)

Intersection ID: 44825	Main Street: SPRING_OAK_DR	Cross Street: HIRAM_ST	Location: SW
ADA ID: 6D26113A6029	Ramp Type: Perp	Initial Pass/Fail: Fail	Overall Compliance: No
Severity Score: 12.5			
Codes/Mitigation Info/Possible Solution		Field Measurements/Component Compliance

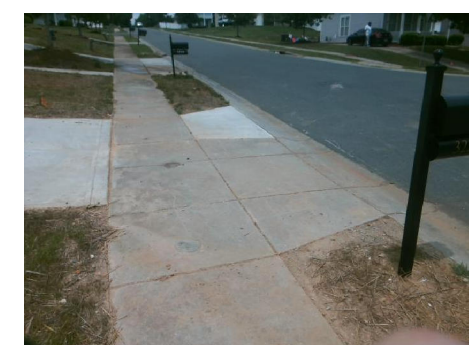
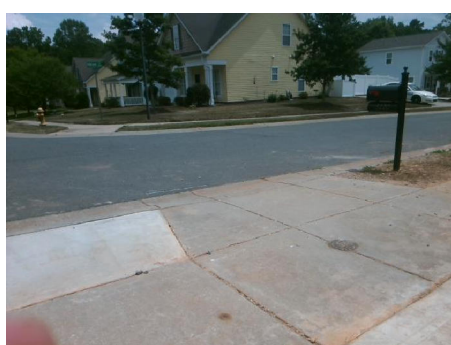
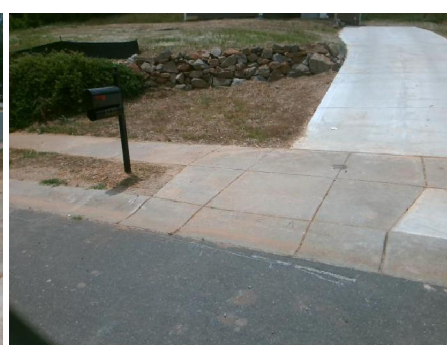
Not Found, R304.5.3

Compliance	Description	Data	Compliance	Description	Data
N/A	Ramp Length (in)	48.5	Yes	Ramp Slope (%)	5.1
Yes	Ramp Width (in)	48.0	No	Ramp XSlope (%)	5.4
N/A	Flare Type LT	N/A	N/A	Flare Type RT	N/A
N/A	Flare Slope LT (%)	N/A	N/A	Flare Slope RT (%)	N/A
N/A	Flare Traversable LT?	N/A	N/A	Flare Traversable RT?	N/A
N/A	Landing Length (in)	N/A	N/A	DWS Provided?	N/A
N/A	Landing Width (in)	N/A	N/A	DWS Contrast?	N/A
N/A	Landing Slope (%)	N/A	N/A	DWS Length (in)	N/A
N/A	Landing X Slope (%)	N/A	N/A	DWS Full Width?	N/A
N/A	Landing Curb? (Y/N)	N/A	N/A	DWS Offset (in)	N/A
N/A	Shared Landing?	N/A			
N/A	Gutter Ponding?	N/A	N/A	Gutter Slope (%)	N/A
N/A	Gutter Lip Ht (in)	N/A	N/A	Gutter X Slope (%)	N/A
N/A	Painted X Walk1?	No	N/A	Painted X Walk2?	N/A
	X Walk 1 Direction	To E		X Walk 2 Direction	N/A
N/A	X Walk 1 Width (in)	N/A	N/A	X Walk 2 Width (in)	N/A
	X Walk 1 Slope (%)	2.2		X Walk 2 Slope (%)	N/A
	X Walk 1 X Slope (%)	4.8		X Walk 2 X Slope (%)	N/A

N/A	Ramp inside XWalk1?	N/A	N/A	Ramp inside XWalk2?	N/A
	Road Slope (%)	N/A	N/A	Clear Space?	N/A
	Road X Slope (%)	N/A	N/A	Clear Space to XWalk (in)	N/A
N/A	Any Obstructions?	N/A	N/A	Storm Grate/Utility Hazard?	N/A
	Obstruction Type			Storm Grate/Utility Type	
		N/A			N/A
			Yes	Surface Condition? (G/P)	Good

Remove & Replace Entire Ramp.

Total Cost: \$ 1850.00
