Access Compliance Report

Public Rights-of-Way

(Curb Ramps)

Intersection ID: 21948	Main Street: SARDIS_RD	Cross Street: SARDIS_RD_NORTH	Location: NE
ADA ID: 6D3B34AA6979	Ramp Type: PerpDiag	Initial Pass/Fail: Fail	Overall Compliance: No
		Severity Score: 8.75

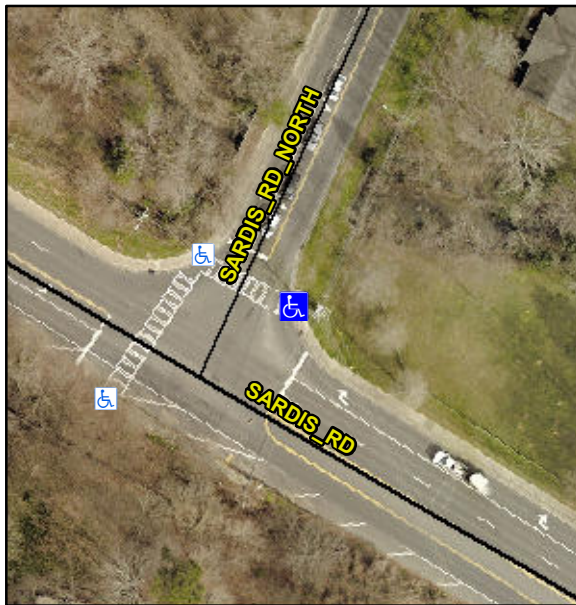
Not Found, R304.5.1

Compliance	Description	Data	Compliance	Description	Data
N/A	Ramp Length (in)	60.0	Yes	Ramp Slope (%)	5.5
No	Ramp Width (in)	42.0	Yes	Ramp XSlope (%)	2.0
N/A	Flare Type LT	N/A	N/A	Flare Type RT	N/A
N/A	Flare Slope LT (%)	N/A	N/A	Flare Slope RT (%)	N/A
N/A	Flare Traversable LT?	N/A	N/A	Flare Traversable RT?	N/A
N/A	Landing Length (in)	N/A	N/A	DWS Provided?	N/A
N/A	Landing Width (in)	N/A	N/A	DWS Contrast?	N/A
N/A	Landing Slope (%)	N/A	N/A	DWS Length (in)	N/A
N/A	Landing X Slope (%)	N/A	N/A	DWS Full Width?	N/A
N/A	Landing Curb? (Y/N)	N/A	N/A	DWS Offset (in)	N/A
N/A	Shared Landing?	N/A			
N/A	Gutter Ponding?	N/A	N/A	Gutter Slope (%)	N/A
N/A	Gutter Lip Ht (in)	N/A	N/A	Gutter X Slope (%)	N/A
N/A	Painted X Walk1?	Yes	N/A	Painted X Walk2?	No
	X Walk 1 Direction	To SW		X Walk 2 Direction	To SE
N/A	X Walk 1 Width (in)	104.0	N/A	X Walk 2 Width (in)	N/A
	X Walk 1 Slope (%)	2.4		X Walk 2 Slope (%)	0.1
	X Walk 1 X Slope (%)	1.6		X Walk 2 X Slope (%)	1.9

N/A	Ramp inside XWalk1?	Yes	N/A	Ramp inside XWalk2?	N/A
	Road Slope (%)	2.6	N/A	Clear Space?	N/A
	Road X Slope (%)	1.9	N/A	Clear Space to XWalk (in)	N/A
N/A	Any Obstructions?	N/A	N/A	Storm Grate/Utility Hazard?	N/A
	Obstruction Type			Storm Grate/Utility Type	
		N/A			N/A
		Yes		Surface Condition? (G/P)	Good

Remove & Replace Curb Ramp With Two New Directional Ramps or Equivalent.
