Access Compliance Report

Public Rights-of-Way

(Curb Ramps)

Intersection ID: 11003	Main Street: CAMP_GREENE_ST	Cross Street: RINGWOOD_ST	Location: NE
ADA ID: 6D3CF5BD06AE	Ramp Type: PerpDiag	Initial Pass/Fail: Fail	Overall Compliance: No
Severity Score: 25			
Codes/Mitigation Info/Possible Solution		Field Measurements/Component Compliance

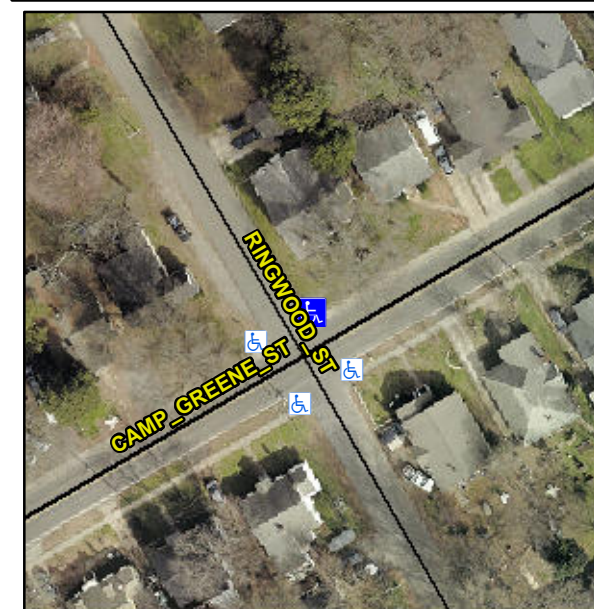
Compliance	Description	Data	Compliance	Description	Data
N/A	Ramp Length (in)	54.0	No	Ramp Slope (%)	10.3
Yes	Ramp Width (in)	51.0	No	Ramp XSlope (%)	5.1
N/A	Flare Type LT	N/A	N/A	Flare Type RT	N/A
N/A	Flare Slope LT (%)	N/A	N/A	Flare Slope RT (%)	N/A
N/A	Flare Traversable LT?	N/A	N/A	Flare Traversable RT?	N/A
N/A	Landing Length (in)	N/A	N/A	DWS Provided?	N/A
N/A	Landing Width (in)	N/A	N/A	DWS Contrast?	N/A
N/A	Landing Slope (%)	N/A	N/A	DWS Length (in)	N/A
N/A	Landing X Slope (%)	N/A	N/A	DWS Full Width?	N/A
N/A	Landing Curb? (Y/N)	N/A	N/A	DWS Offset (in)	N/A
N/A	Shared Landing?	N/A			
N/A	Gutter Ponding?	N/A	N/A	Gutter Slope (%)	N/A
N/A	Gutter Lip Ht (in)	N/A	N/A	Gutter X Slope (%)	N/A
N/A	Painted X Walk1?	No	N/A	Painted X Walk2?	No
	X Walk 1 Direction	To W		X Walk 2 Direction	To S
N/A	X Walk 1 Width (in)	N/A	N/A	X Walk 2 Width (in)	N/A
	X Walk 1 Slope (%)	1.0		X Walk 2 Slope (%)	4.3
	X Walk 1 X Slope (%)	2.3		X Walk 2 X Slope (%)	3.3

N/A	Ramp inside XWalk1?	N/A	N/A	Ramp inside XWalk2?	N/A
	Road Slope (%)	3.4	N/A	Clear Space?	N/A
	Road X Slope (%)	0.7	N/A	Clear Space to XWalk (in)	N/A
N/A	Any Obstructions?	N/A	N/A	Storm Grate/Utility Hazard?	N/A
	Obstruction Type			Storm Grate/Utility Type	
		N/A			N/A
			Yes	Surface Condition? (G/P)	Good

Remove & Replace Curb Ramp With Two New Directional Ramps or Equivalent.
