Access Compliance Report

Public Rights-of-Way

(Curb Ramps)

Intersection ID: 10020374	Main Street: BALLANTYNE CORPORATE PK	Cross Street: N/A	Location:	N
ADA ID: 6D57DF1AE13C	Ramp Type: BlendTrans1	Initial Pass/Fail: Fail	Overall Compliance: No	Severity Score: 12.5
Codes/Mitigation Info/Possible Solution		Field Measurements/Component Compliance

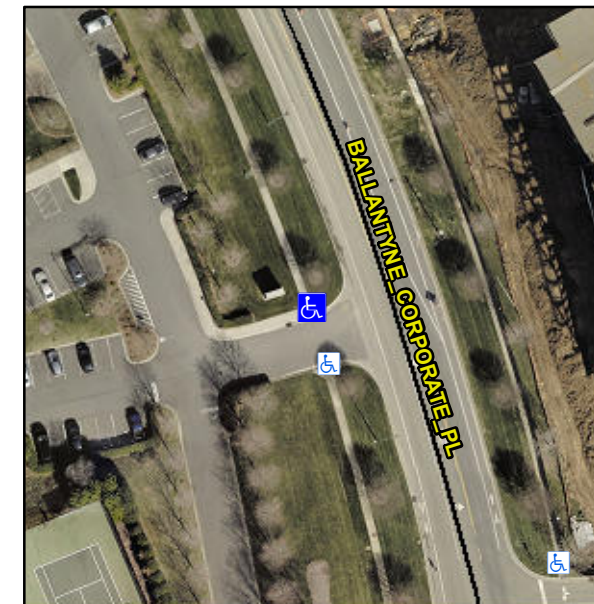
Not Found, R304.5.3

Compliance	Description	Data	Compliance	Description	Data
N/A	Ramp Length (in)	60.0	Yes	BlendTrans Slope (%)	2.9
Yes	Ramp Width (in)	48.0	No	BlendTrans XSlope (%)	5.7
N/A	Flare Type LT	N/A	N/A	Flare Type RT	N/A
N/A	Flare Slope LT (%)	N/A	N/A	Flare Slope RT (%)	N/A
N/A	Flare Traversable LT?	N/A	N/A	Flare Traversable RT?	N/A
N/A	Landing Length (in)	N/A	N/A	DWS Provided?	N/A
N/A	Landing Width (in)	N/A	N/A	DWS Contrast?	N/A
N/A	Landing Slope (%)	N/A	N/A	DWS Length (in)	N/A
N/A	Landing X Slope (%)	N/A	N/A	DWS Full Width?	N/A
N/A	Landing Curb? (Y/N)	N/A	N/A	DWS Offset (in)	N/A
N/A	Shared Landing?	N/A			
N/A	Gutter Ponding?	N/A	N/A	Gutter Slope (%)	N/A
N/A	Gutter Lip Ht (in)	N/A	N/A	Gutter X Slope (%)	N/A
N/A	Painted X Walk1?	No	N/A	Painted X Walk2?	N/A
	X Walk 1 Direction	To S		X Walk 2 Direction	N/A
	X Walk 1 Width (in)	N/A		X Walk 2 Width (in)	N/A
	X Walk 1 Slope (%)	3.6		X Walk 2 Slope (%)	N/A
	X Walk 1 X Slope (%)	7.5		X Walk 2 X Slope (%)	N/A

N/A	Ramp inside XWalk1?	N/A	N/A	Ramp inside XWalk2?	N/A
	Road Slope (%)	7.5		Clear Space?	N/A
	Road X Slope (%)	3.6	N/A	Clear Space to XWalk (in)	N/A
N/A	Any Obstructions?	N/A	N/A	Storm Grate/Utility Hazard?	N/A
	Obstruction Type			Storm Grate/Utility Type	
		N/A			N/A
			Yes	Surface Condition? (G/P)	Good
			No	Curb Slope (%)	17.0

Possible Solutions:

Remove & Replace Curb Ramp With Two New Directional Ramps or Equivalent.
