Access Compliance Report

Public Rights-of-Way

(Curb Ramps)

Intersection ID: 10116	Main Street: MILL_RD	Cross Street: SOLOMON_ST	Location: SW
ADA ID: 6D59E433A51C	Ramp Type: Perp	Initial Pass/Fail: Fail	Overall Compliance: No
		Severity Score: 55

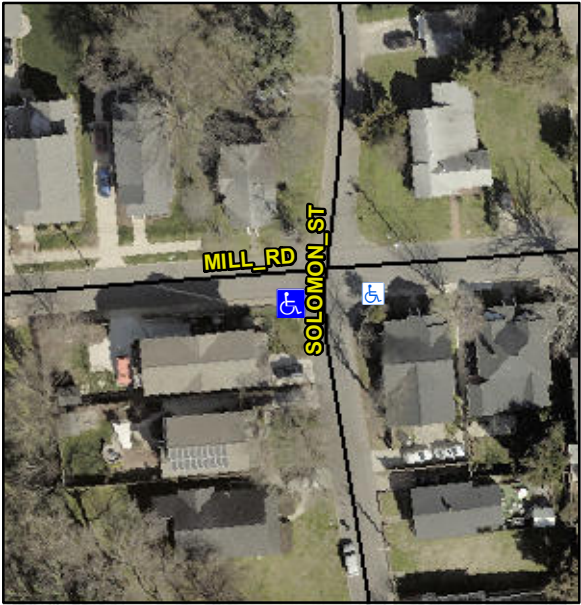
Possible Solutions:		Compliance	Description	Data	
	Remove & Replace Entire Ramp.		N/A	Ramp Length (in)	34.0	No
			No	Ramp Width (in)	35.0	No
			N/A	Flare Type LT	N/A	N/A
			N/A	Flare Slope LT (%)	N/A	N/A
			N/A	Flare Traversable LT?	N/A	N/A
			N/A	Landing Length (in)	N/A	N/A
			N/A	Landing Width (in)	N/A	N/A
			N/A	Landing Slope (%)	N/A	N/A
			N/A	Landing X Slope (%)	N/A	N/A
			N/A	Landing Curb? (Y/N)	N/A	N/A
			N/A	Shared Landing?	N/A	
			N/A	Gutter Ponding?	N/A	N/A
			N/A	Gutter Lip Ht (in)	N/A	N/A
			N/A	Painted X Walk1?	No	N/A
				X Walk 1 Direction	To E	N/A
			N/A	X Walk 1 Width (in)	N/A	N/A
				X Walk 1 Slope (%)	5.4	N/A
				X Walk 1 X Slope (%)	2.4	N/A
			N/A	Ramp inside XWalk1?	N/A	N/A
<p>Surveyor Notes:</p> <p>N/A</p> <p>PROW/ADA:</p> <p>Not Found, R304.5.1, R304.2.2, R304.5.3</p>			N/A	Road Slope (%)	N/A	N/A
			N/A	Road X Slope (%)	N/A	N/A

N/A	Any Obstructions?	N/A	N/A
				Obstruction Type		
					N/A	N/A
			Yes	Surface Condition? (G/P)	Good	
Total Cost:		\$ 1850.00
