Access Compliance Report

Public Rights-of-Way

(Curb Ramps)

Intersection ID: 49273	Main Street: REMINISCE_LN	Cross Street: REUNION_ST	Location: NE
ADA ID: 6D8BD89B05AB	Ramp Type: BlendTrans1	Initial Pass/Fail: Fail	Overall Compliance: No
		Severity Score: 25

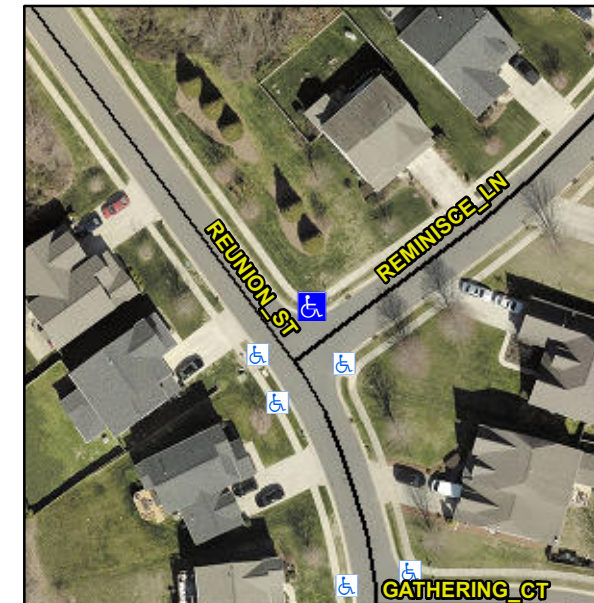
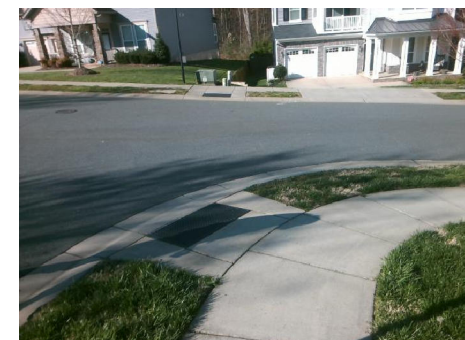
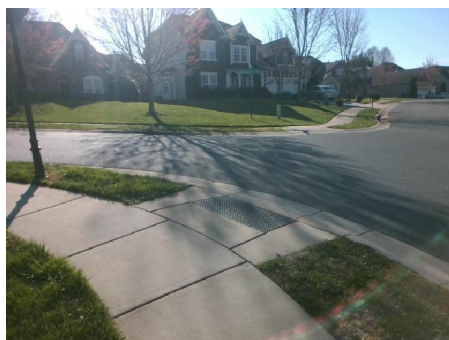
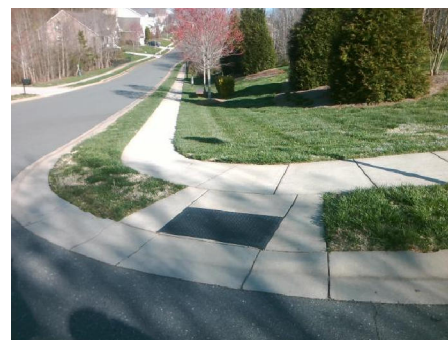
Not Found, R304.5.3

Compliance	Description	Data	Compliance	Description	Data
N/A	Ramp Length (in)	48.5	Yes	BlendTrans Slope (%)	4.1
Yes	Ramp Width (in)	48.0	No	BlendTrans XSlope (%)	11.0
N/A	Flare Type LT	N/A	N/A	Flare Type RT	N/A
N/A	Flare Slope LT (%)	N/A	N/A	Flare Slope RT (%)	N/A
N/A	Flare Traversable LT?	N/A	N/A	Flare Traversable RT?	N/A
N/A	Landing Length (in)	N/A	N/A	DWS Provided?	N/A
N/A	Landing Width (in)	N/A	N/A	DWS Contrast?	N/A
N/A	Landing Slope (%)	N/A	N/A	DWS Length (in)	N/A
N/A	Landing X Slope (%)	N/A	N/A	DWS Full Width?	N/A
N/A	Landing Curb? (Y/N)	N/A	N/A	DWS Offset (in)	N/A
N/A	Shared Landing?	N/A			
N/A	Gutter Ponding?	N/A	N/A	Gutter Slope (%)	N/A
N/A	Gutter Lip Ht (in)	N/A	N/A	Gutter X Slope (%)	N/A
N/A	Painted X Walk1?	No	N/A	Painted X Walk2?	No
	X Walk 1 Direction	To SW		X Walk 2 Direction	To SE
	X Walk 1 Width (in)	N/A		X Walk 2 Width (in)	N/A
	X Walk 1 Slope (%)	5.0		X Walk 2 Slope (%)	2.1
	X Walk 1 X Slope (%)	6.9		X Walk 2 X Slope (%)	8.8

N/A	Ramp inside XWalk1?	N/A	N/A	Ramp inside XWalk2?	N/A
	Road Slope (%)	10.8		Clear Space?	N/A
	Road X Slope (%)	0.7	N/A	Clear Space to XWalk (in)	N/A
N/A	Any Obstructions?	N/A	N/A	Storm Grate/Utility Hazard?	N/A
	Obstruction Type			Storm Grate/Utility Type	
		N/A			N/A
			Yes	Surface Condition? (G/P)	Good
			No	Curb Slope (%)	6.5

Remove & Replace Curb Ramp With Two New Directional Ramps or Equivalent.

Total Cost: \$ 3200.00
